# Watershed Emergency Response Team (WERT) 2024 Line Fire

CA-BDF-012520

November 6, 2024

**REPORT TITLE:** Watershed Emergency Response Team (WERT) Evaluation – 2024 Line Fire

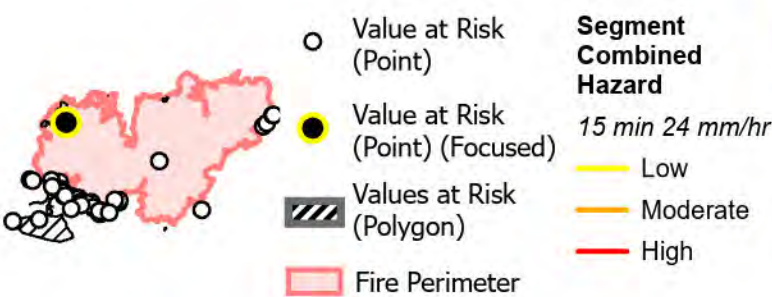
**Description:** 8' CMP culvert from basin burned at mostly moderate and high. Burned trash rack with debris plugging potential. 50' high culvert crossing creates a large-sized detention basin.

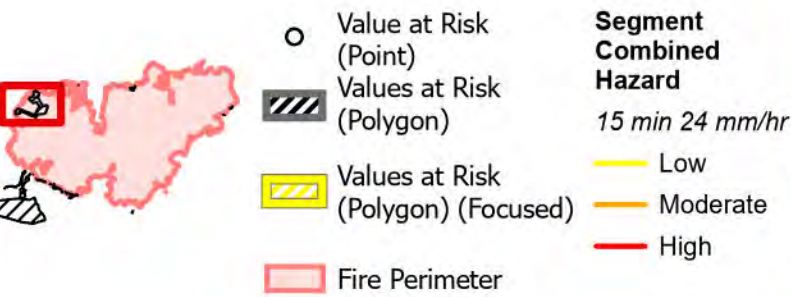
Description: High potential for flows to impact roadway throughout highway. Rockfalls likely in steep areas with loose rocks. Multiple small drainages with active channels that empty onto roadway.

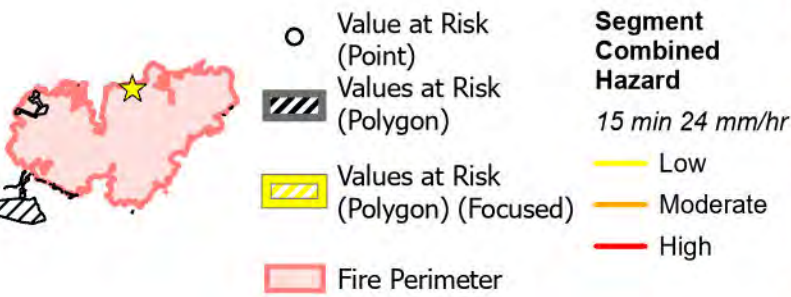
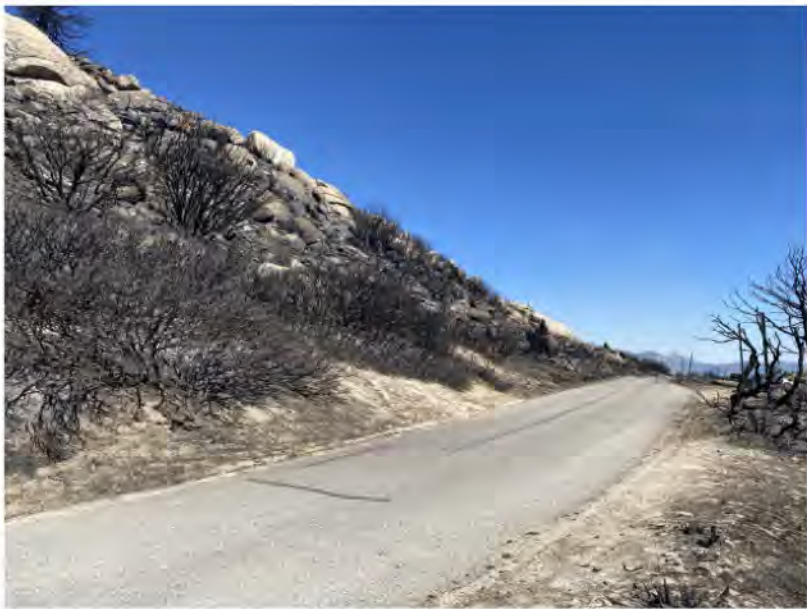
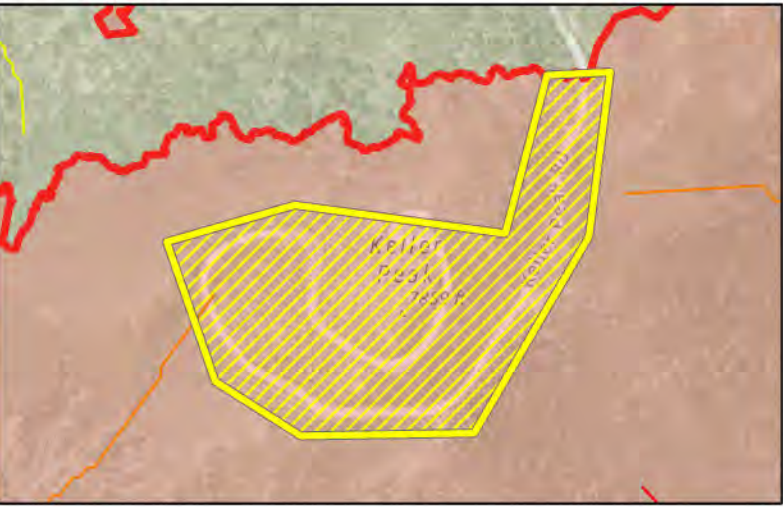
**Description:** Severely burned slope with large granitic boulders and daylighted bedrock throughout. Rain may mobilize sand (grus) and deposit along roadway.

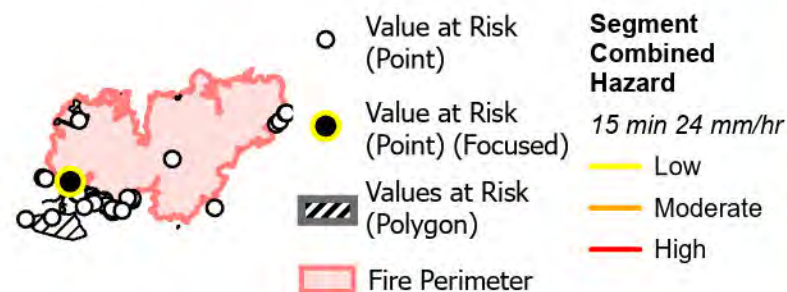
**Description:** Drainage outlets into v-ditch that runs adjacent to north side yard. Rear yard fencing includes block wall and wrought iron. Upslope basin is relatively small, with the upper portion burned at low severity.

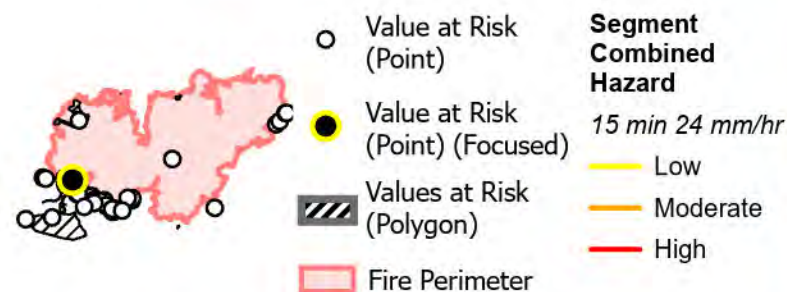
**Description:** Upstream basin relatively small and burned at low severity with some moderate. Evidence of past overtopping was observed that included minor scour on downstream slope of crossing. Culvert is 48-inch CMP with top of pipe about 2 ft below road surface.

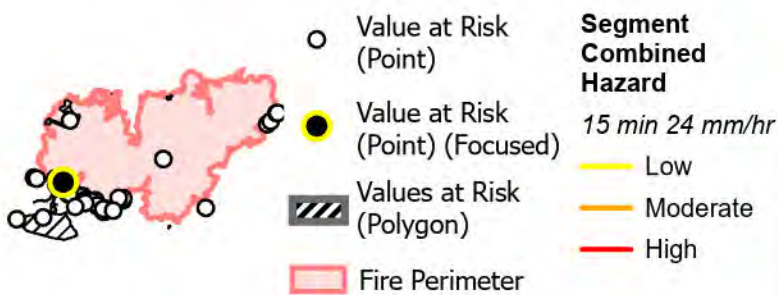
**Description:** Upstream basin is small and burned at low severity. No notable incision in drainage channel. Unknown if rear yard fence wall was designed / constructed as an impact / diversion wall.

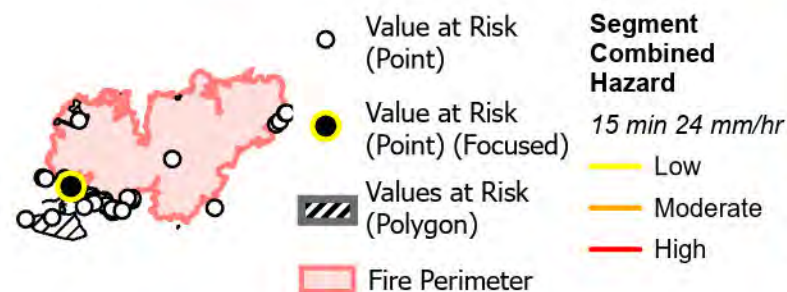
**Description:** Crossing consists of 36" CMP drop structure to pipe that extends below paved roadway. Debris has accumulated around inlet from recent rains. Upstream basin is small and burned at low severity. Concrete v-ditch leading to inlet is about 8' wide at crest by 3' deep.

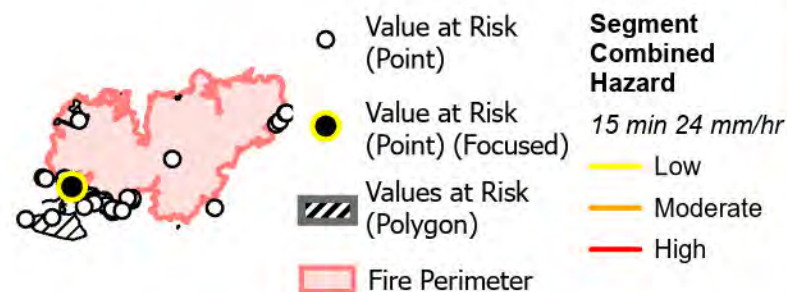
**Description:** Small basin burned at low severity drains to small v-ditch directed toward rear yard of home. V-ditch extends below block wall, running through rear / side yard to street.

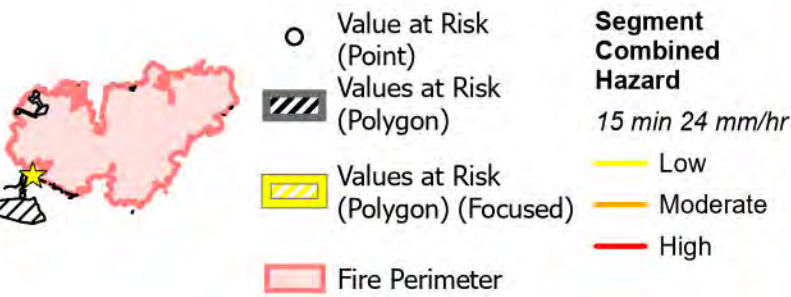
**Description:** Upslope drainage burned at moderate severity. Some k-rail has been placed to impede / maintain flow down access road, with some k-rail retaining 1-2 ft of sediment.

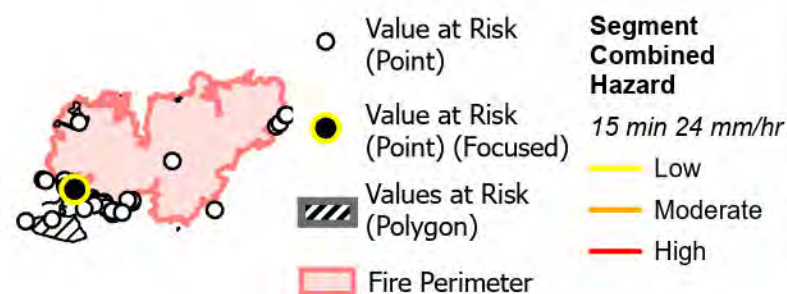
**Description:** Moderately sized basin burned at low severity. Tank is situated on a fill pad that has essentially plugged the canyon. Drainage broadens just upstream of tank, but limited area for flow around improvements. K rail has been installed to help protect structures and direct flow around tank and along / down access road toward Pleasant View Lane.

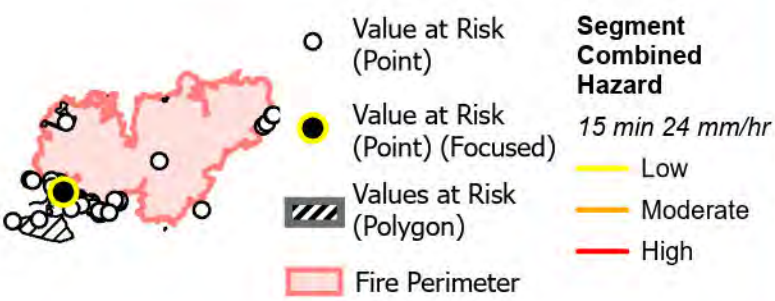
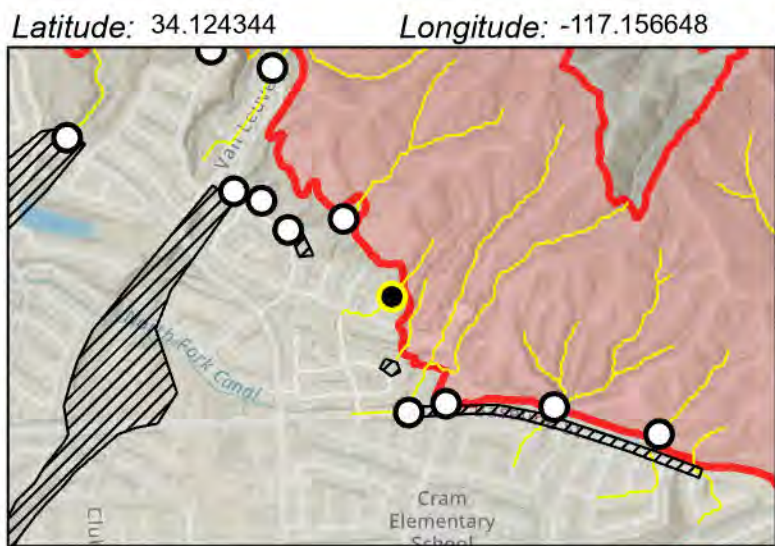
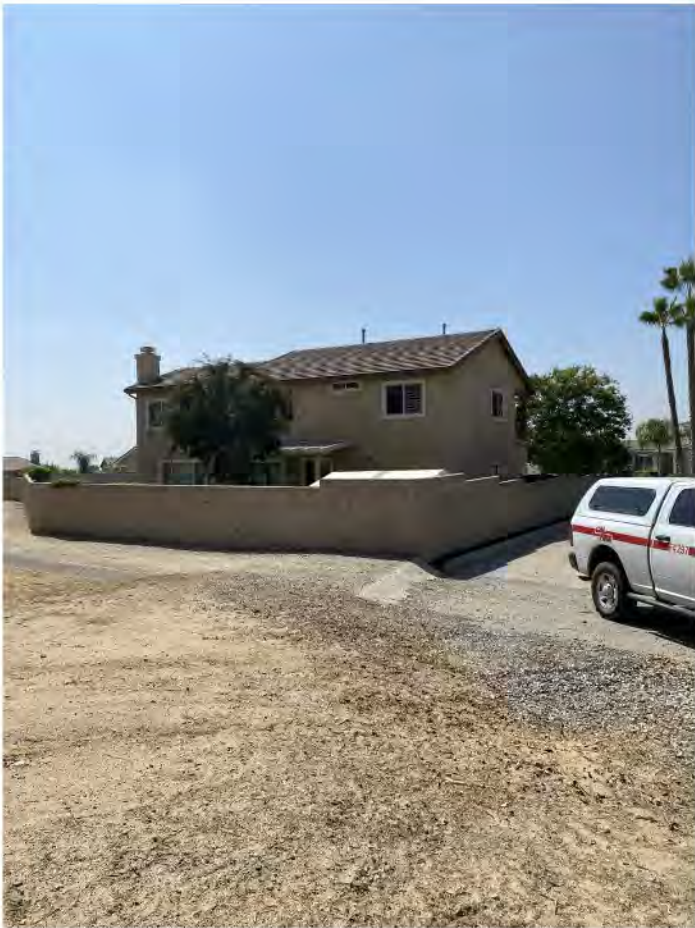
**Description:** Basin burned at low severity. No incised channel but drainage has U-shape feature with abundant sediment.

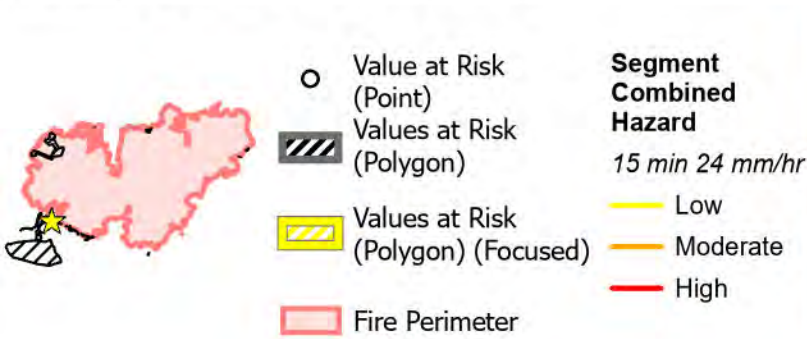
Description: The basin is moderately sized and burned at low severity. There is a small upstream debris basin that could be overwhelmed during a significant storm event, and overtopping flows would follow down along access roads and directed toward the rear yard of homes.
