# Watershed Emergency Response Team (WERT) 2024 Line Fire

CA-BDF-012520

November 6, 2024

**REPORT TITLE:** Watershed Emergency Response Team (WERT) Evaluation – 2024 Line Fire

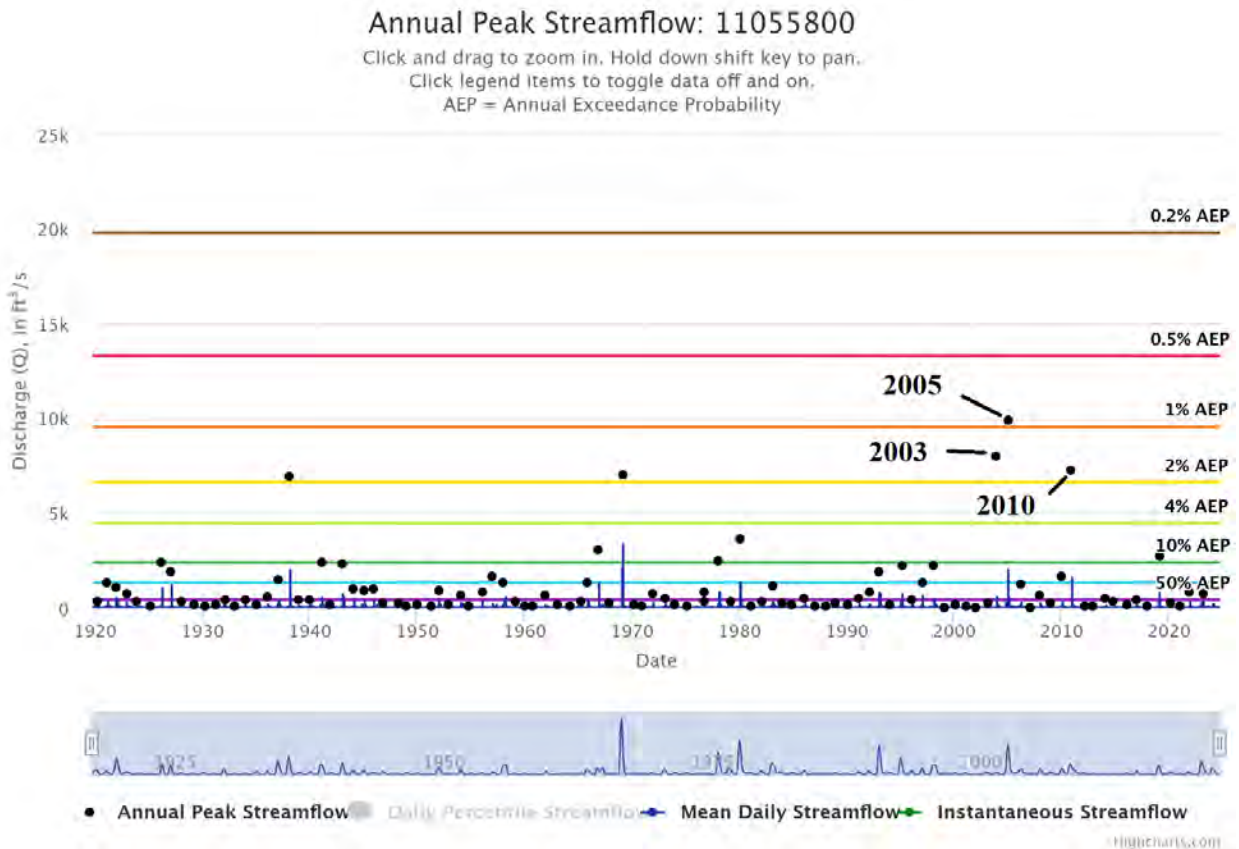
**Figure 2.** Annual peak streamflow for the USGS City Creek near Highland CA gage (11055800) that highlights the top 3 flow events from 1920 to present. (Source: StreamStats (streamstats.usgs.gov)).

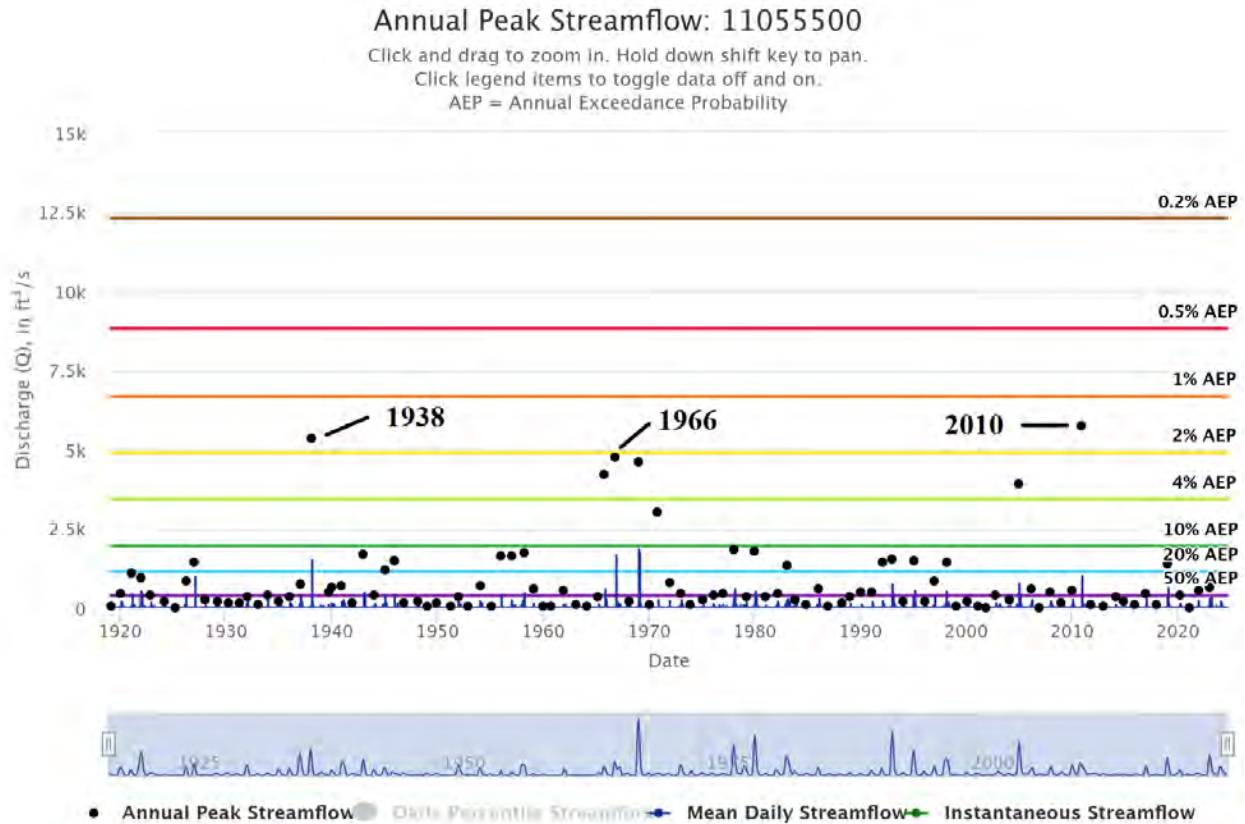
**Figure 3.** Annual peak streamflow for the USGS Plunge Creek near East Highlands CA gage (11055500) that highlights the top 3 flow events from 1919 to present. (Source: StreamStats ([streamstats.usgs.gov](https://streamstats.usgs.gov))).

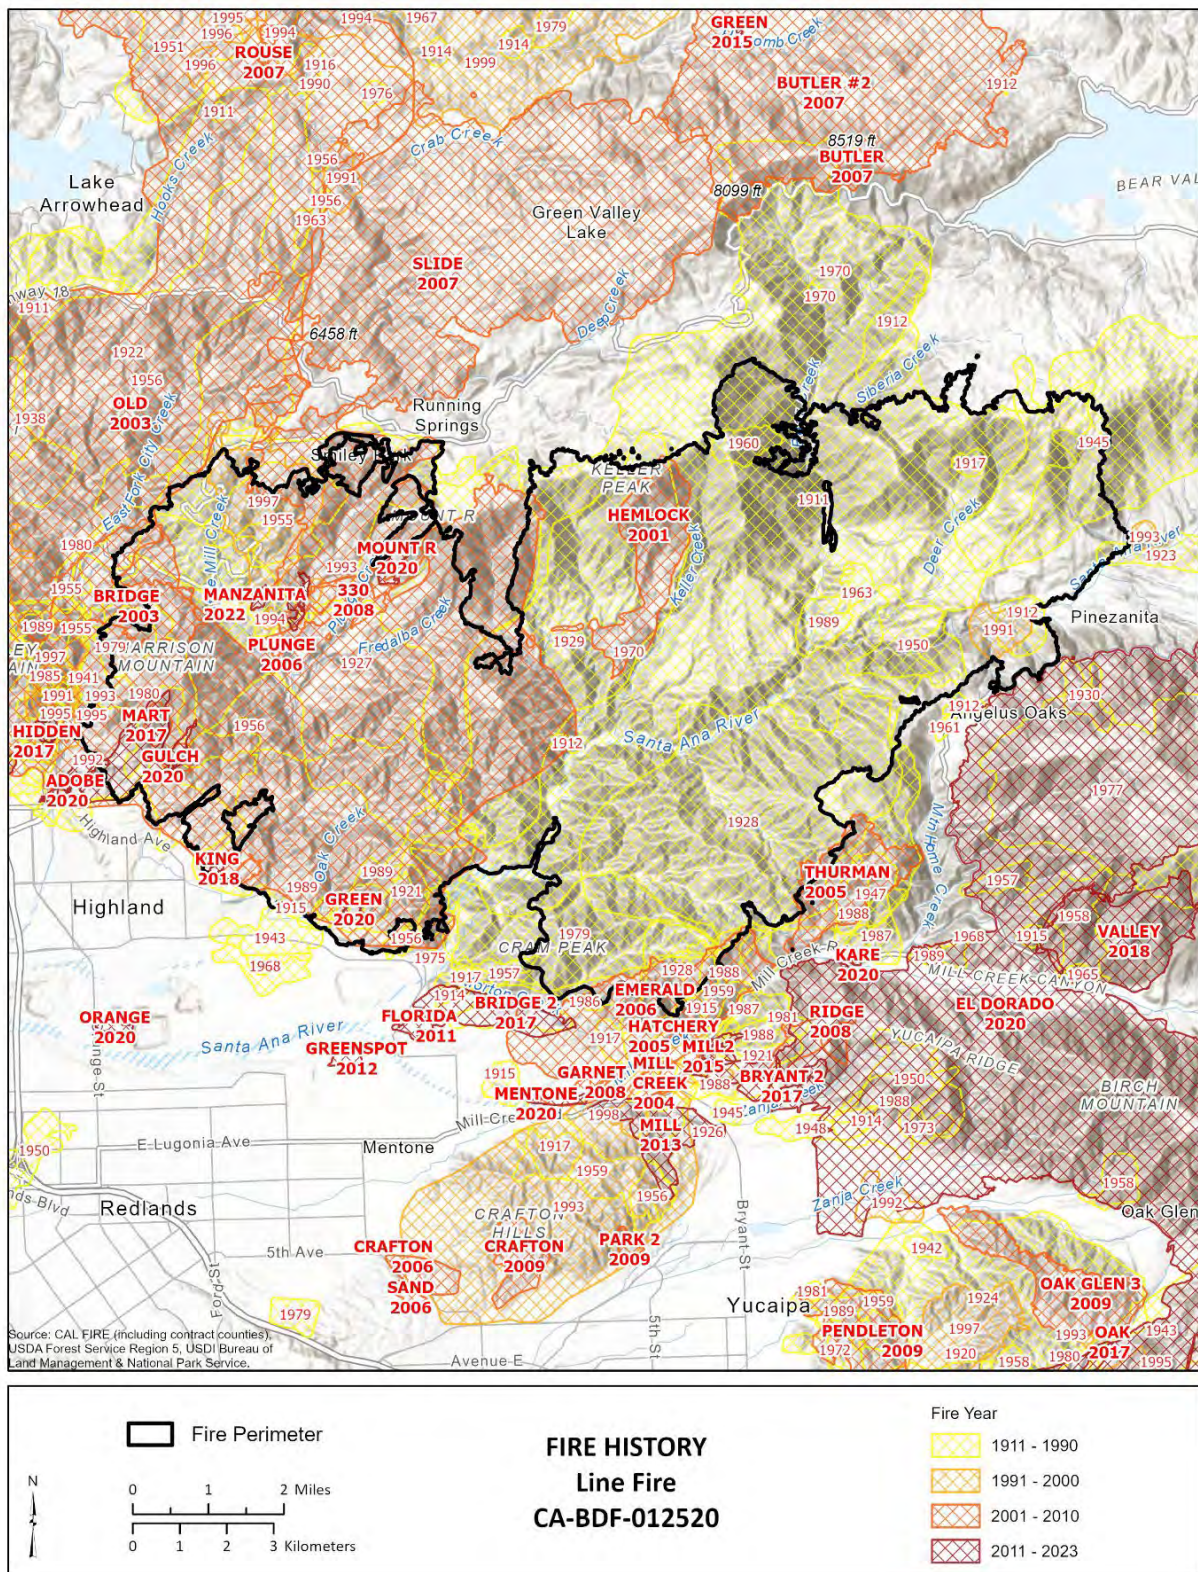
Much of the eastern half of the fire, particularly the Santa Ana River drainage, has not experienced wildfire activity in the last 40 years (MTBS, 2024). Areas with less recent fire activity or no recorded fire history might have a higher potential for postfire response due to higher fuel loading which might lead to more severely damaged soil. Also, since these areas have not been subjected to recent postfire erosional processes, they may have a more abundant supply of sediment that can be entrained by amplified postfire runoff.

**The Figure 6.** Fire history for the Line Fire. Note: Areas that haven't burned for many decades have a potentially higher erosional response than areas that have been subject to recent fire.

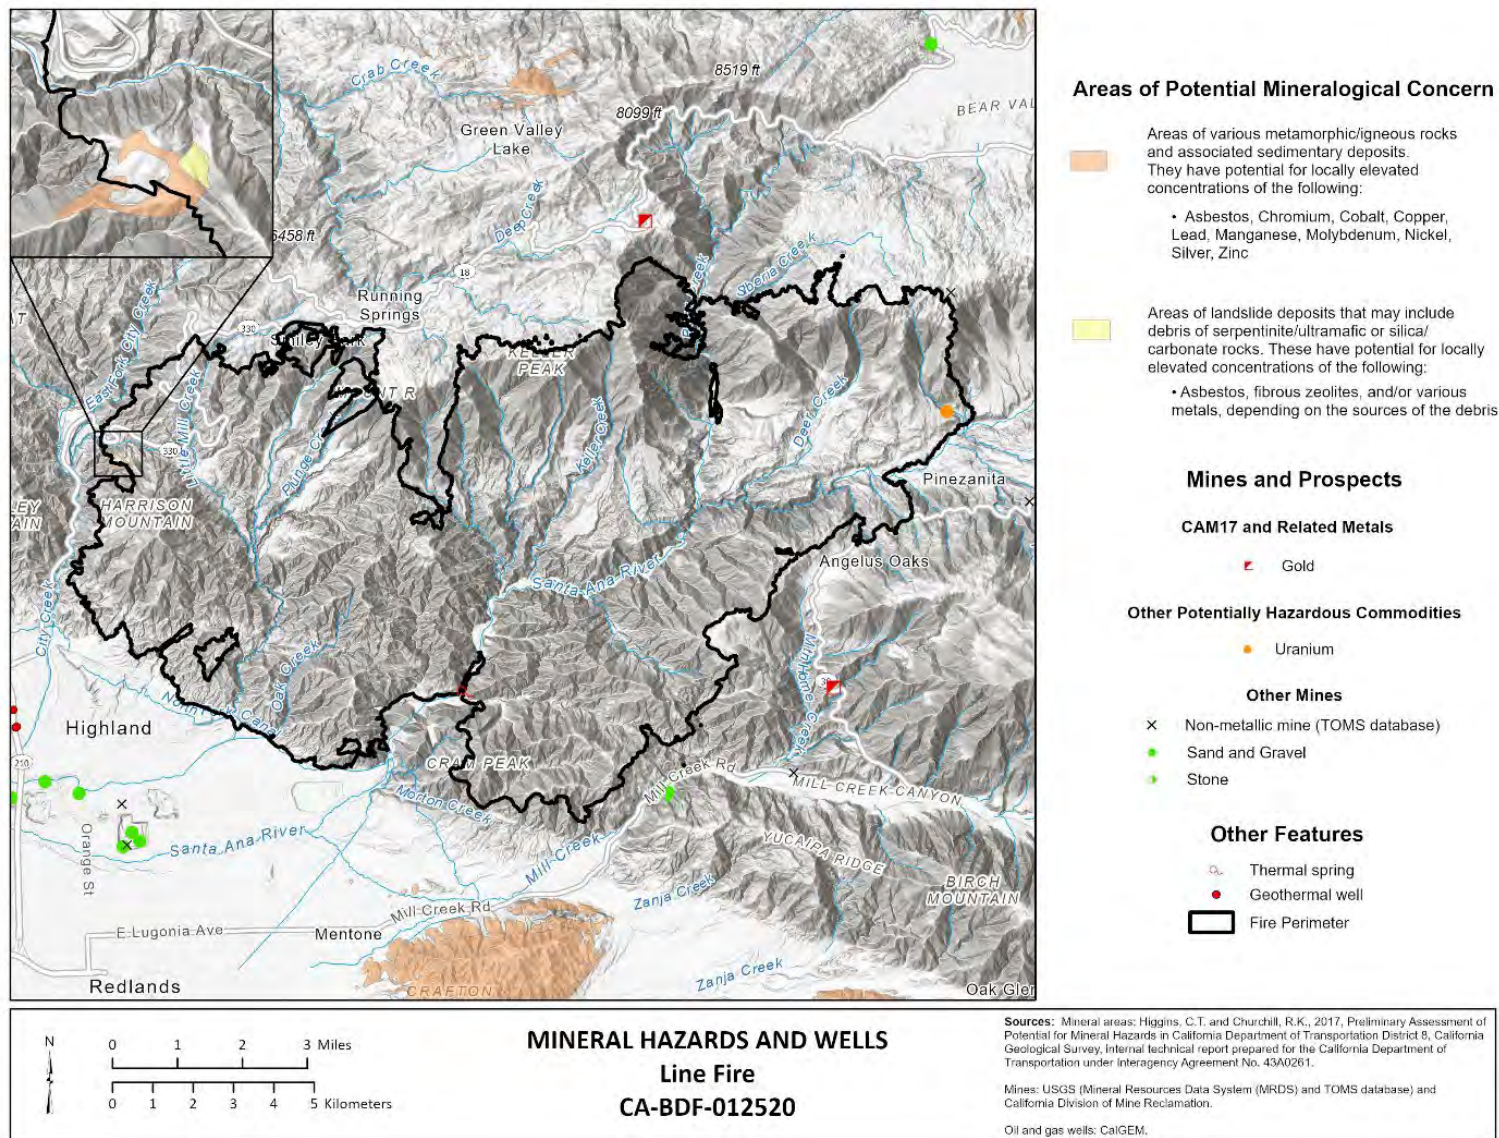
Postfire effects reduce vegetative cover and increase the potential of airborne dust and runoff that can mobilize hazardous minerals associated with naturally occurring asbestos and heavy metals associated with mines. Bedrock potentially containing naturally occurring asbestos is located on the far western margin of the fire area near Highway 330 (see inset, Figure 7).

Postfire hydrologic responses pose an increase in risk for water quality by mobilizing asbestos- and metal-rich surface deposits into streams within and downstream of the burned area. Since this geologic unit is relatively small in area, is far removed from sensitive receptors, and is not within a watershed of a known water source for the City of Highland, health effects stemming from this rock unit is considered negligible.

**Figure 7.** Mineral Hazards and Wells map for the Line Fire.

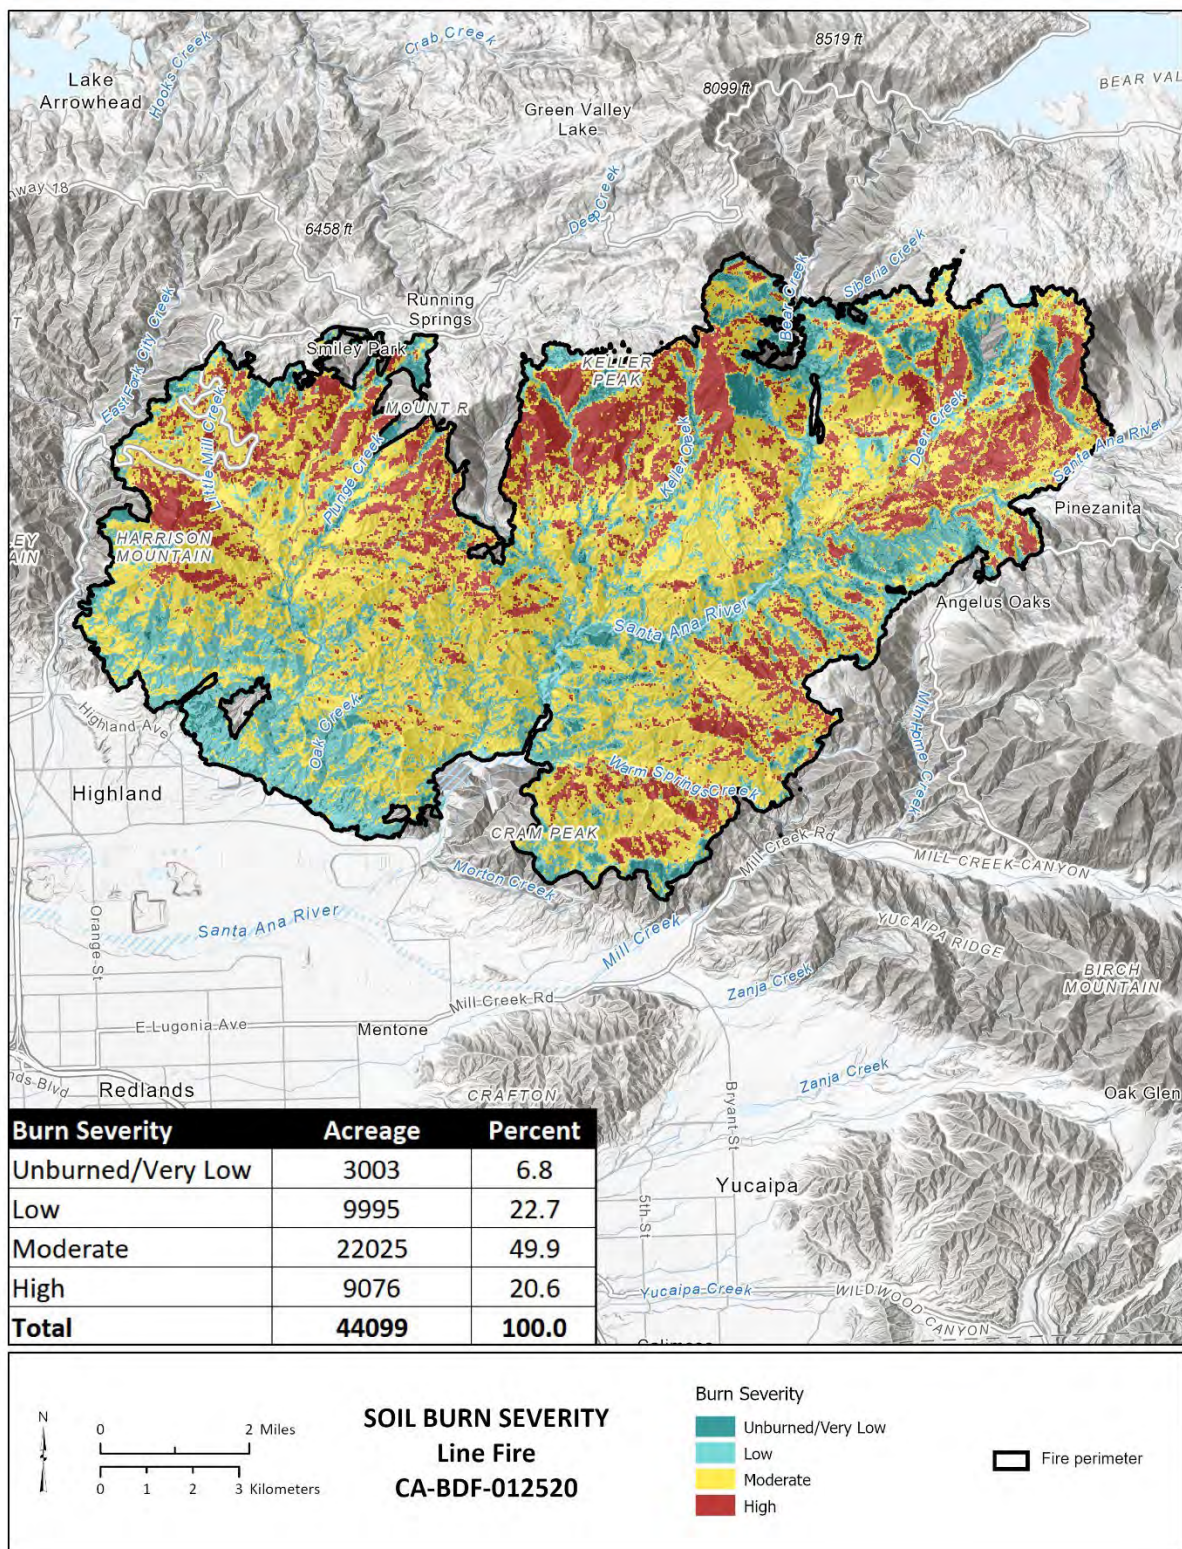
A Soil Burn Severity (SBS) map of the burn area (Figure 8) was provided by the USFS BAER team assigned to the Line Fire. Within the Line Fire footprint, 23 percent of the area was burned at low, 50 percent at moderate, 20 percent at high and 7 percent as very low/unburned soil burn severity. Some of the highest proportions of moderate and high soil burn severity are located within steep mountainous terrain along the northern and eastern portions of the fire within the Santa Ana River, Plunge Creek, and City Creek drainages.

**Figure 8.** Soil Burn Severity map for the Line Fire.

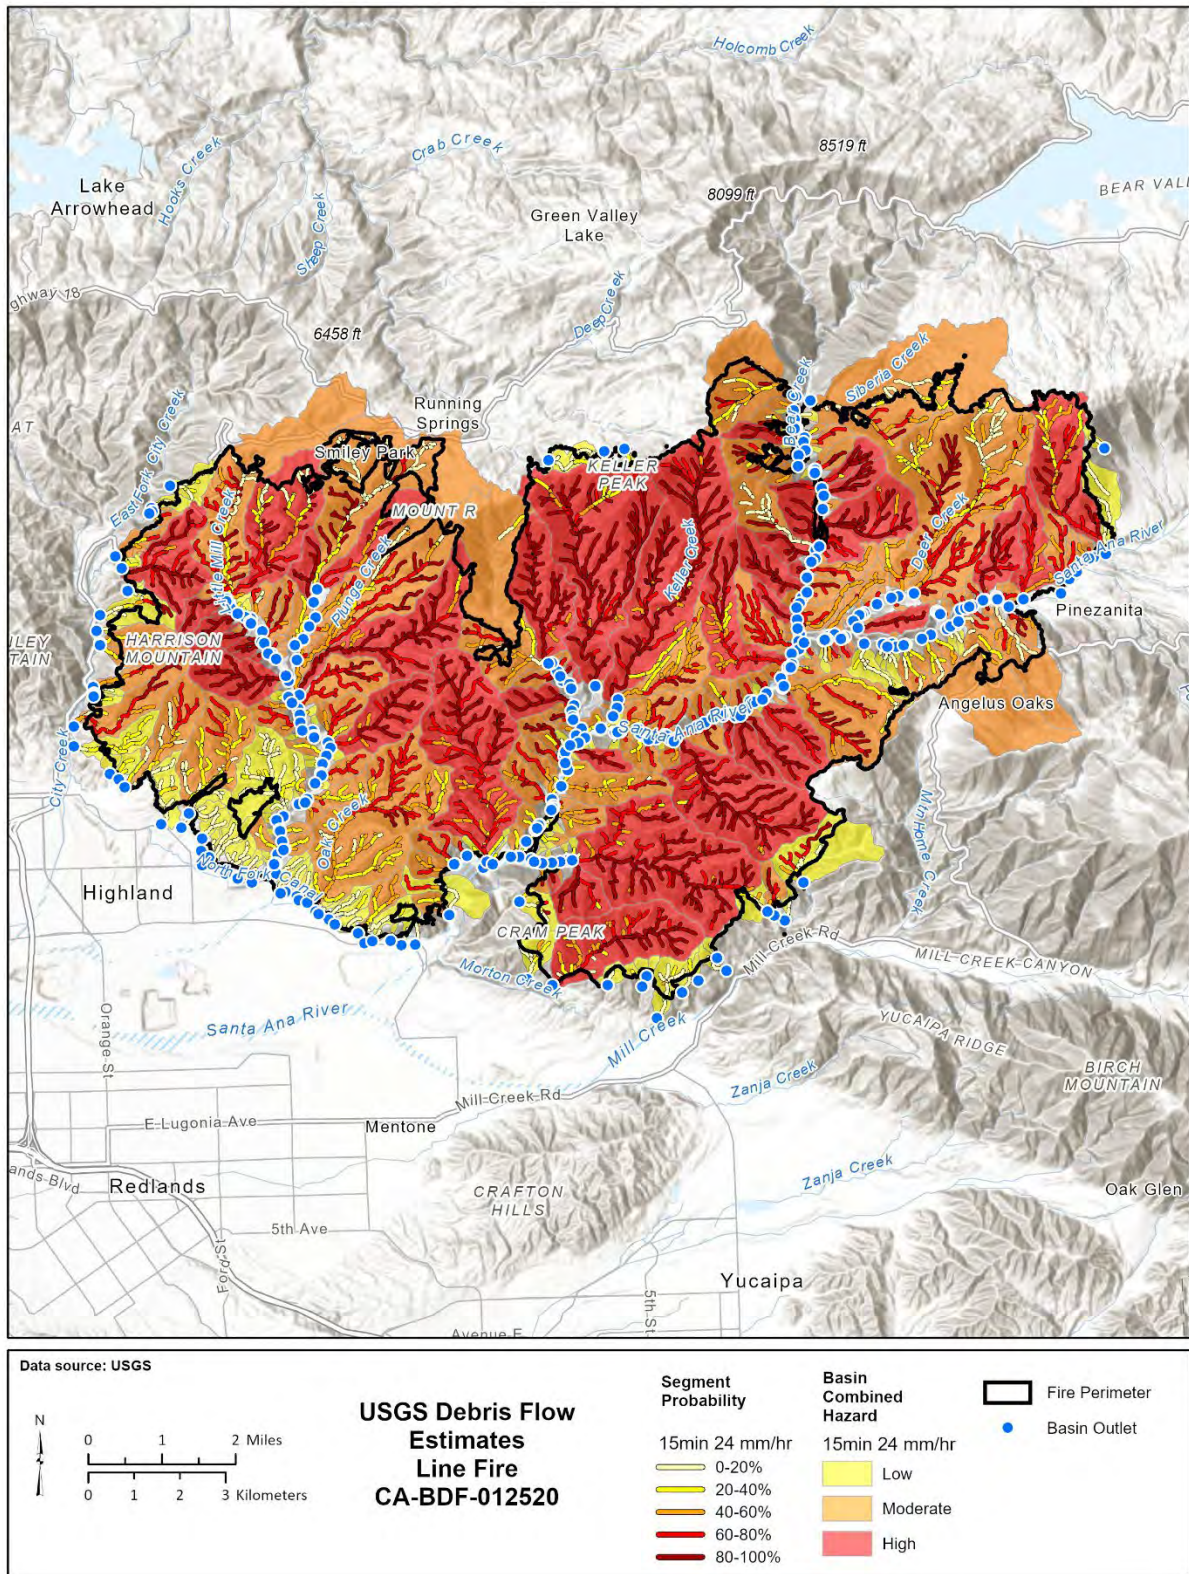
The USGS postfire debris flow hazard model (Staley et al., 2016) was run using the SBS map for the Line Fire to assist in the WERT's assessment of locations where hazards to life, property, and infrastructure may exist. The combined hazard model results reflect the potential likelihood of a debris flow occurring as well as the volumetric yield of the debris flow. These results are combined into an overall categorical ranking that range from low to high. Figure 9 shows the combined debris flow hazard for the 15-minute, 24 mm/hr (0.94 in/hr) intensity storm. Figure 9 indicates that the combined debris flow hazard is predominantly moderate and high throughout the burn scar, with some low hazard along the southern mountain front in lower elevation terrain. Figure 10 illustrates 15-minute rainfall intensities required to generate a 50 percent likelihood of debris flows for each basin across the burned area. The fire-wide basin average 15-minute rainfall intensity threshold is about 31.9 mm/hr (1.3 in/hr). Basins with high debris flow hazard rankings are typically in remote areas. These debris flows should have minimal immediate downstream impacts, but they may supply large quantities of sediment and debris to mainstream channels (e.g., Plunge Creek) that may be transported to downstream reaches and eventually impact infrastructure. Communities within the City of Highland contain the most densely populated and developed areas that may directly be impacted by post-fire debris floods / flows. Subdivisions that line the mountain front contain multiple homes that are located near basin outlets or are adjacent to historic channels with a combined hazard ranking of moderate and high. Damage to stream crossings along State Highway 330 is also possible.

**Figure 9.** Combined debris flow hazard on the Line Fire for the 24 mm/hr (0.94 in/hr) 15-minute storm event.

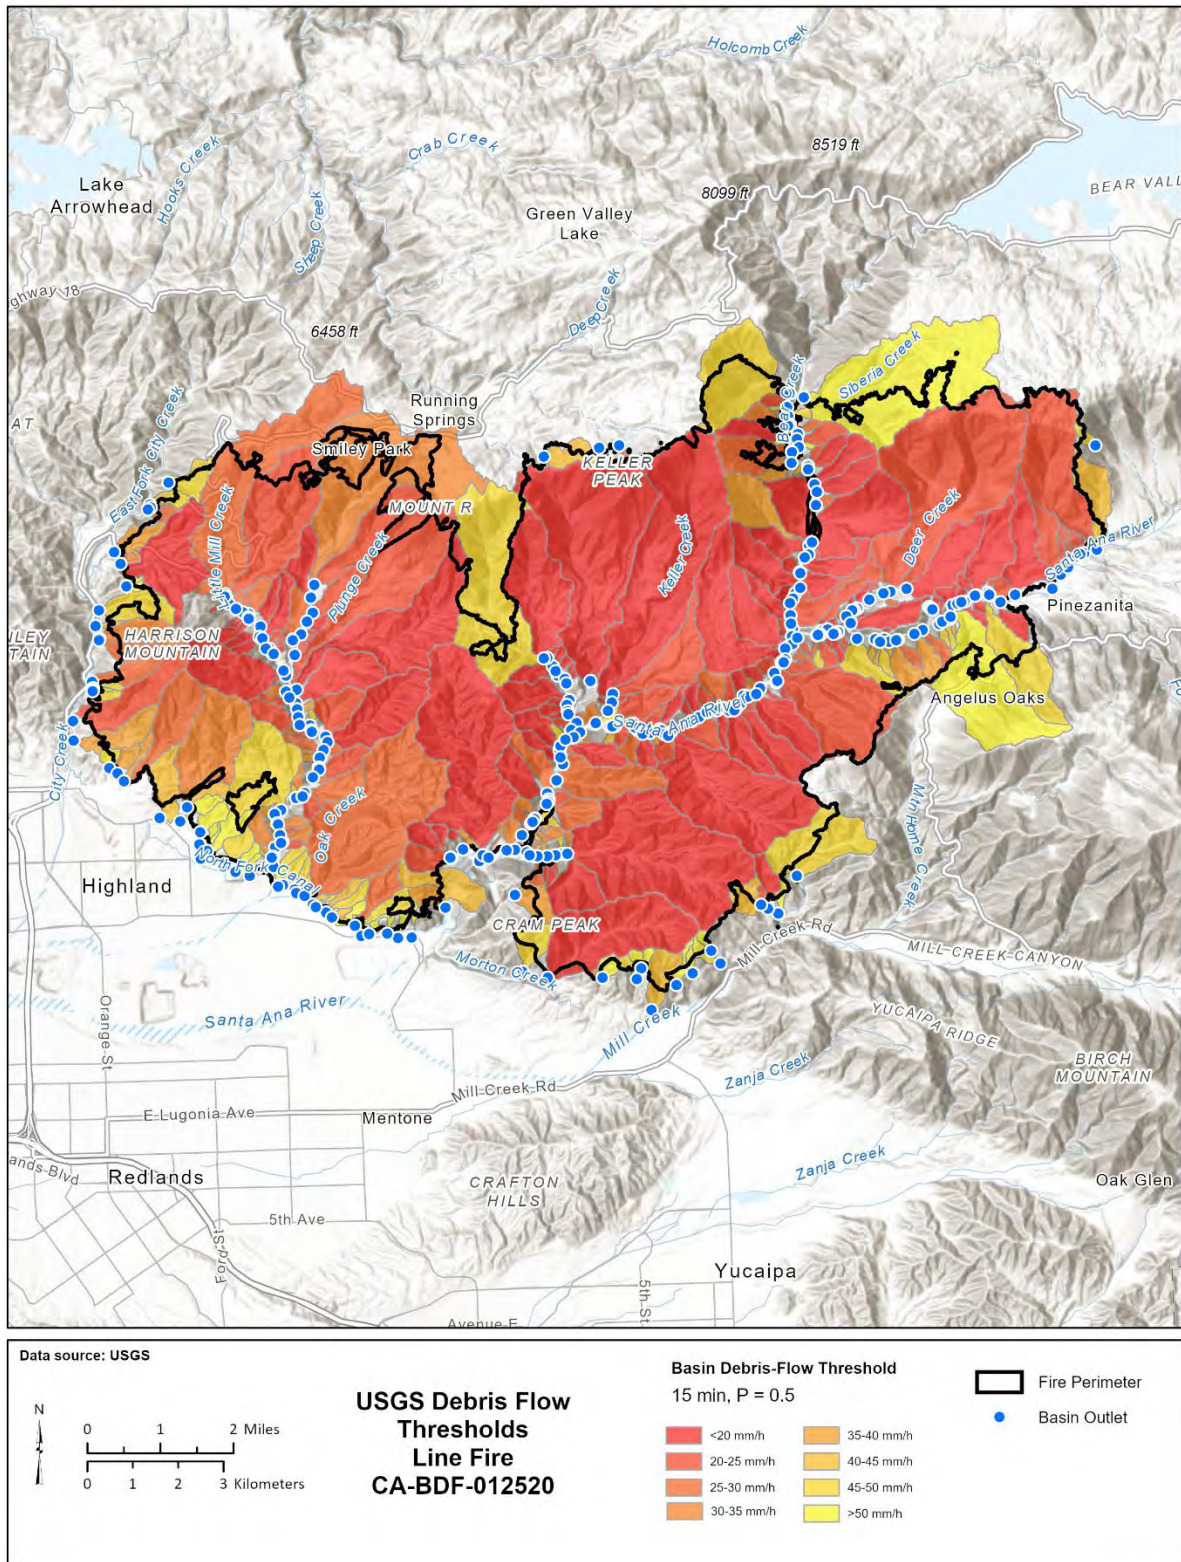
**Figure 10.** Predicted 15-minute rainfall intensity with a 50 percent likelihood of triggering a debris flow for the Line Fire.

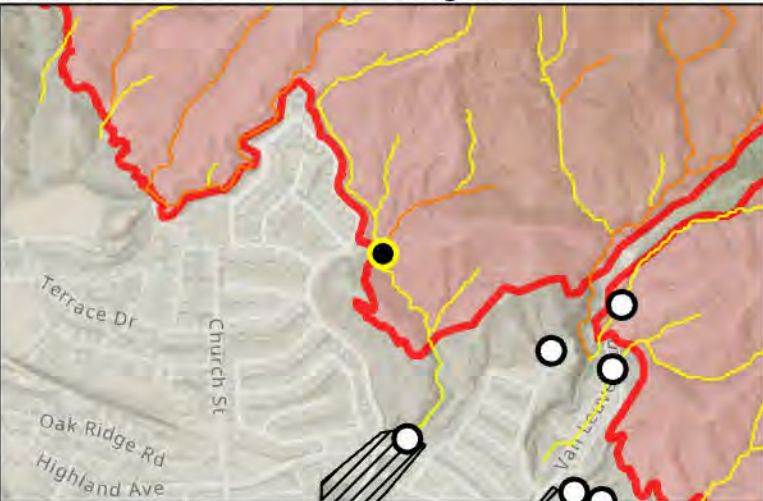
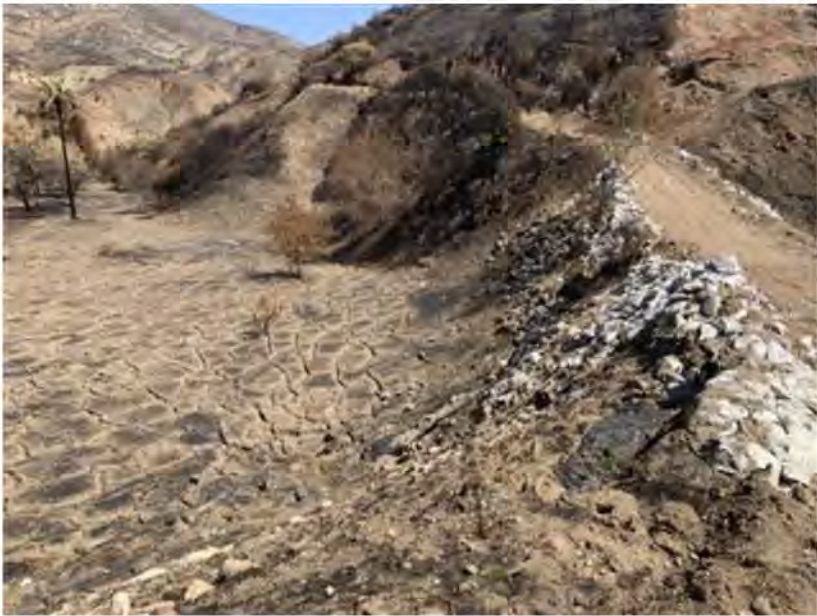
**Field Observation or** Large fill crossing has no observed structure (for example no culvert), water is draining out of base of fill, fill is  
**Potential Hazard:** about 60' thick on downstream side, 25' on upstream.

The fill crossing is acting as a basin that appears to be trapping debris and filling up. Overtopping and or dam failure possible. Possible probability of occurrence with moderate consequence = Intermediate risk.

**Potential Hazard to Life: low**

**Potential Hazard to Property: high**

**Description:** Basin may need clearing. Need approximate volume of existing sediment in basin. Appears ~25% full. Significant elevation difference between upstream and downstream side: ~40 ft.

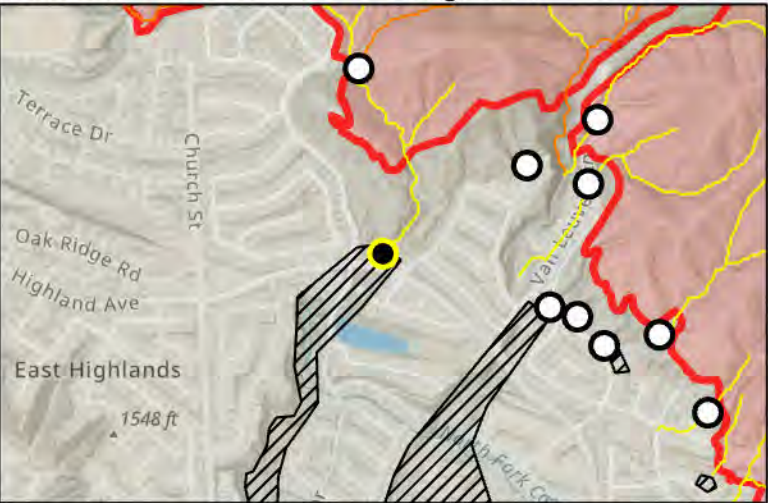
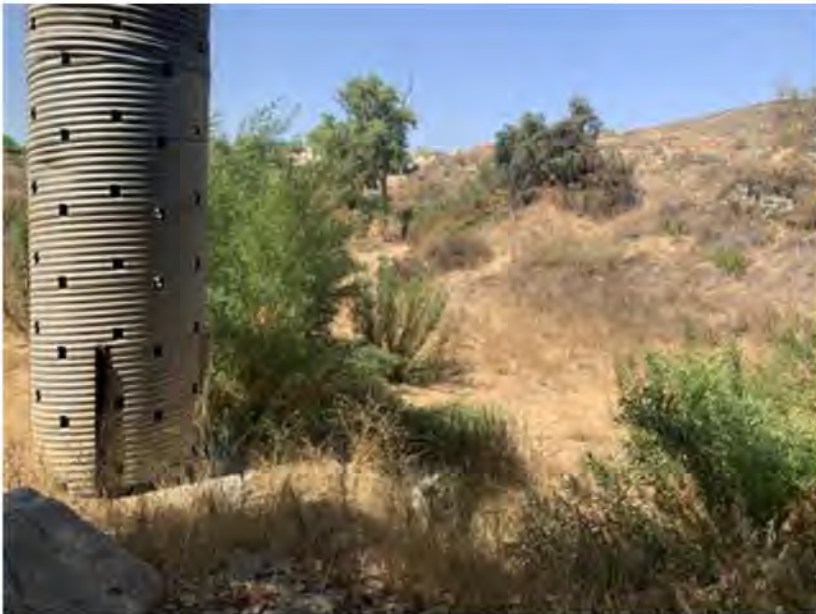
**Field Observation or** Debris basin with standpipe. Potential hazard is debris flow plugging standpipe and filling basin, with potential to  
**Potential Hazard:** overtop and impact downstream watercourse.

**Potential Hazard to Life: low**

**Potential Hazard to Property: high**

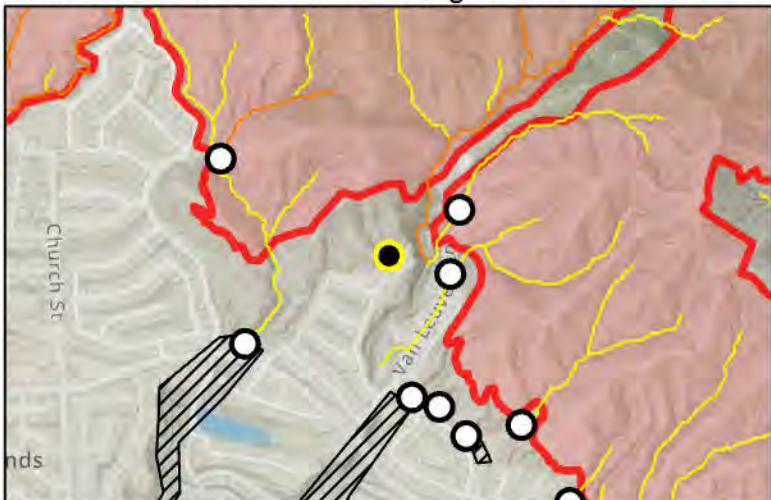
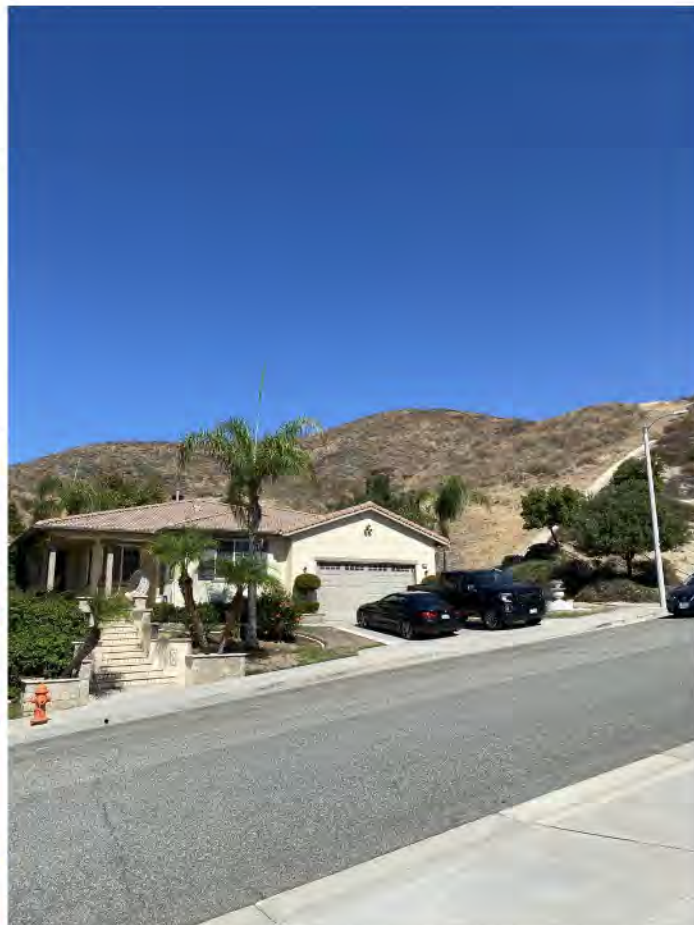
**Field Observation or** Residence located at the outlet of a small drainage. The potential hazard is debris flood that could avulse from

**Potential Hazard:** concrete drainage ditch and impact rear yard, swimming pool, and residence.

**Potential Hazard to Life: low**

**Potential Hazard to Property: moderate**

**Description:** Drainage outlets into v-ditch that runs adjacent to north side yard. Rear yard fencing includes block wall and wrought iron. Upslope basin is relatively small, with the upper portion burned at low severity.

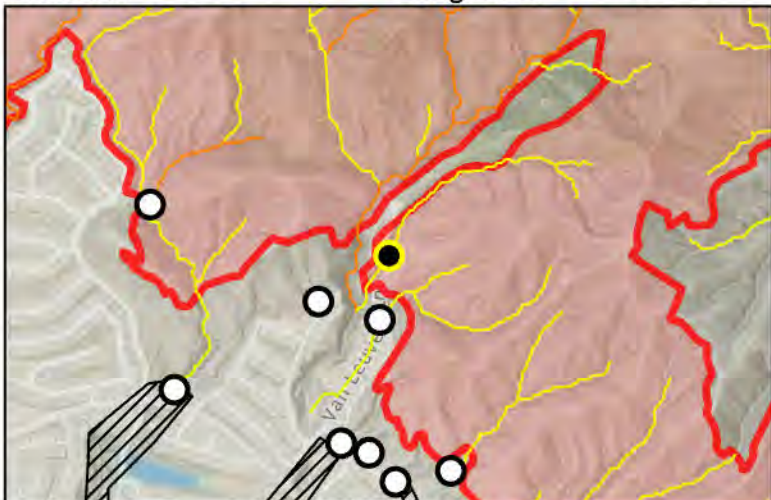
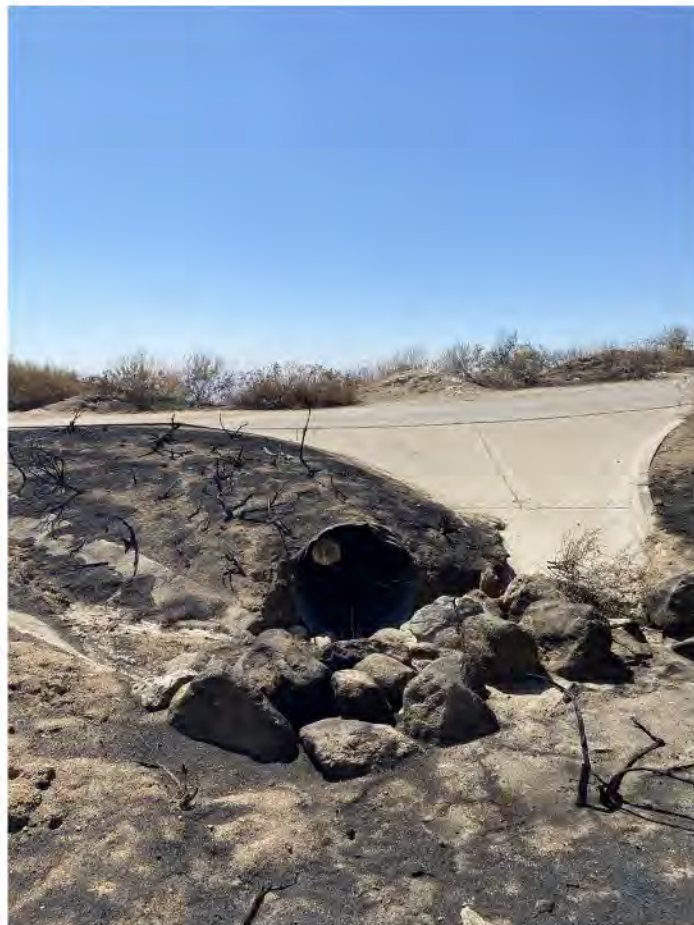
**Field Observation or Potential Hazard:** Culverted road crossing providing access to water tank. Potential hazard is plugging of culvert with debris, leading to overtopping and nuisance flooding along paved access road.

**Potential Hazard to Life: low**

**Potential Hazard to Property: low**

**Description:** Upstream basin relatively small and burned at low severity with some moderate. Evidence of past overtopping was observed that included minor scour on downstream slope of crossing. Culvert is 48-inch CMP with top of pipe about 2 ft below road surface.

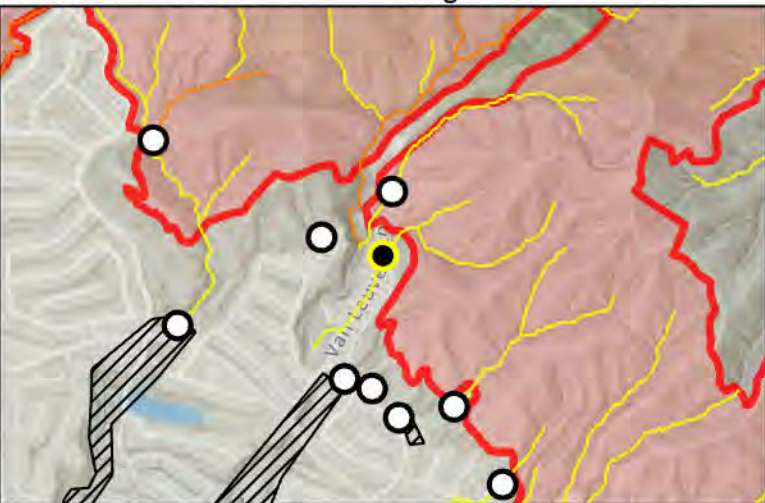
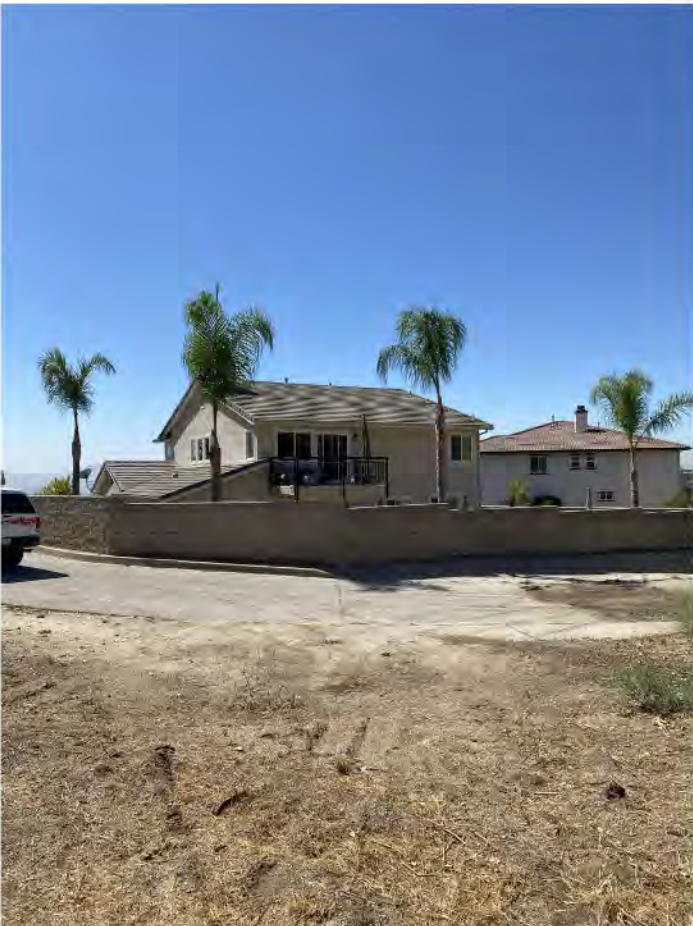
**Field Observation or** Residence located at the outlet of a small drainage. Potential hazard is debris flow / flood that could mobilize  
**Potential Hazard:** burnt debris and sediment and impact property fence wall and rear yard of residence.

**Potential Hazard to Life: low**

**Potential Hazard to Property: low**

**Description:** Upstream basin is small and burned at low severity. No notable incision in drainage channel. Unknown if rear yard fence wall was designed / constructed as an impact / diversion wall.

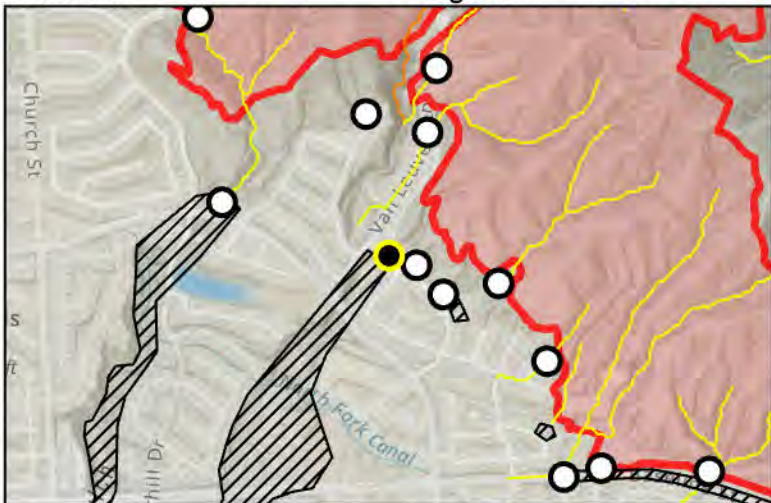
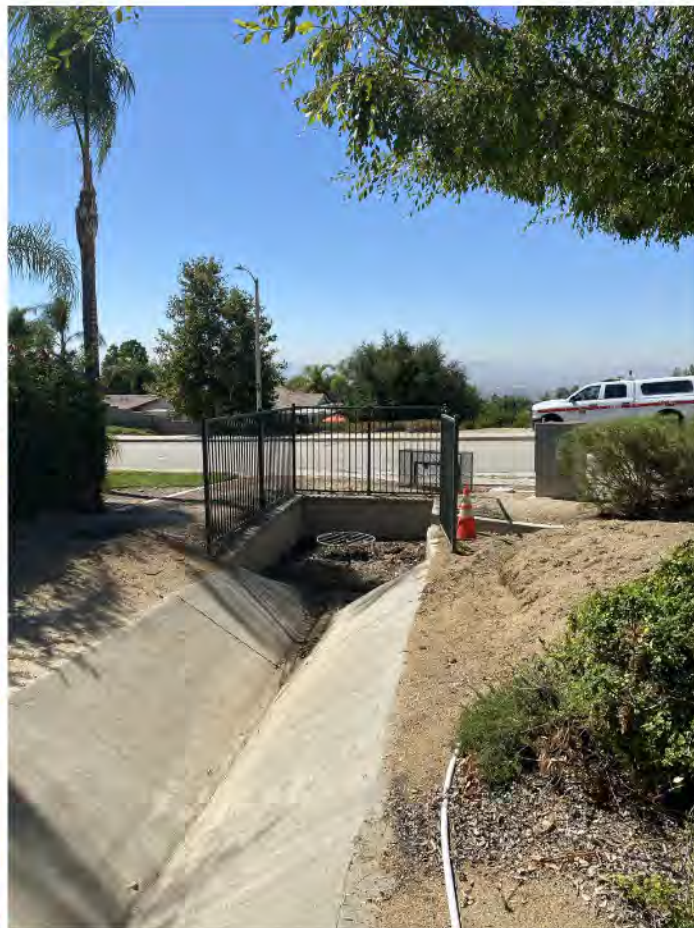
**Field Observation or** Culverted road crossing. Potential hazard is plugging of culvert with debris, leading to overtopping, impacting

**Potential Hazard:** road surface with overland flow being directed easterly along Pleasant View Lane.

**Potential Hazard to Life: low**

**Potential Hazard to Property: low**

**Description:** Crossing consists of 36" CMP drop structure to pipe that extends below paved roadway. Debris has accumulated around inlet from recent rains. Upstream basin is small and burned at low severity. Concrete v-ditch leading to inlet is about 8' wide at crest by 3' deep.

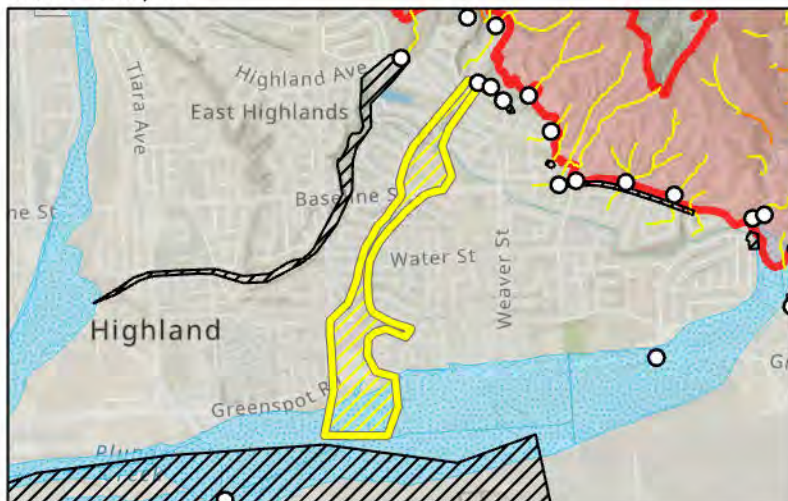
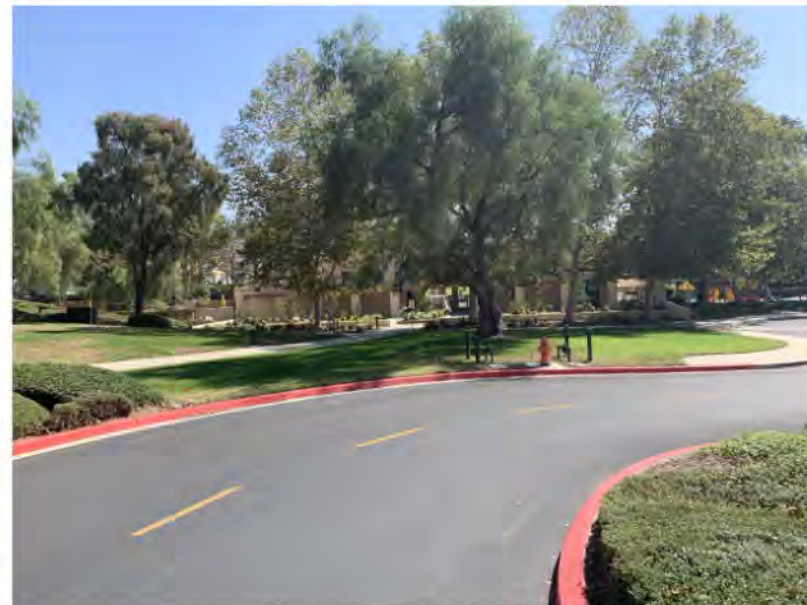
**Field Observation or Potential Hazard:** Inundation area along former Elder Gulch drainage that is converted to a walkway.

**Potential Hazard to Life: high**

**Potential Hazard to Property: high**

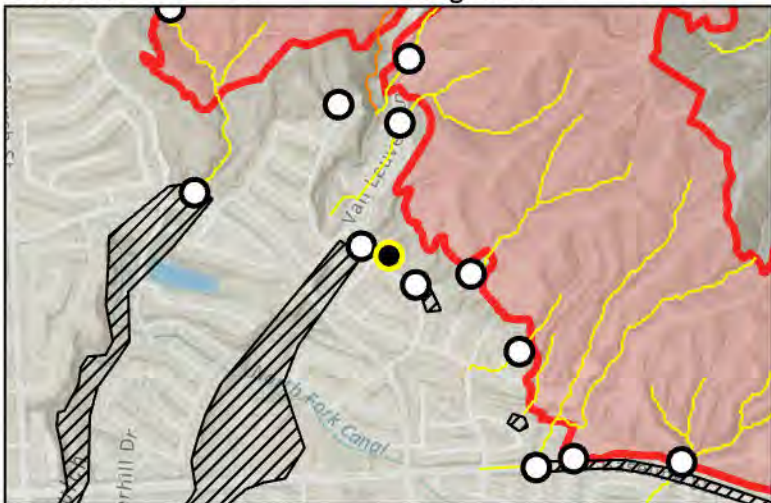
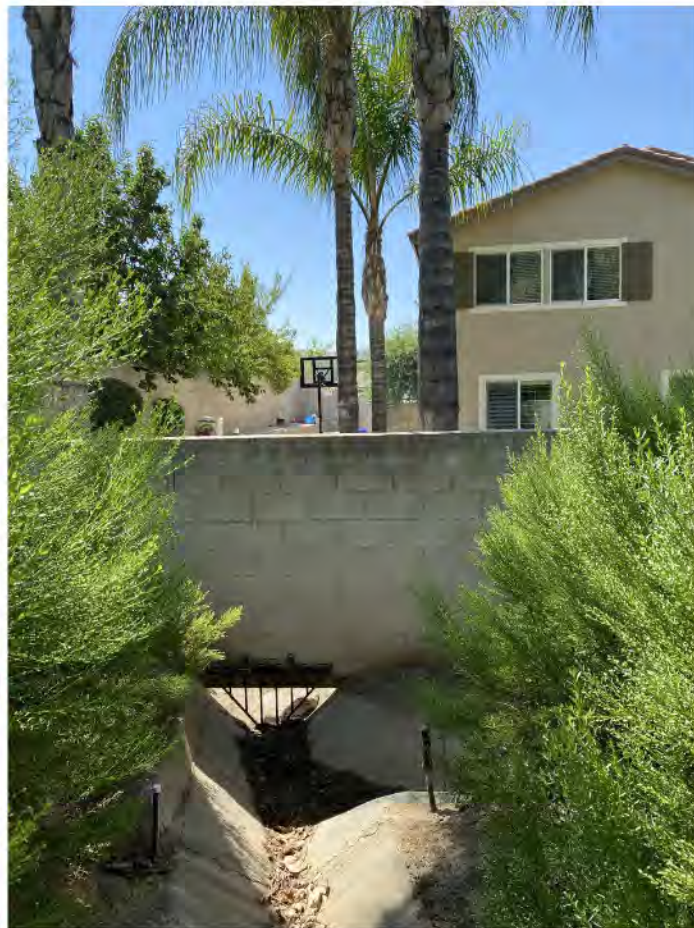
**Potential Hazard:** fence wall and through residence yard. Potential hazard is for flood / debris flood to impact residence and rear yard.

**Potential Hazard to Life: low**

**Potential Hazard to Property: low**

**Description:** Small basin burned at low severity drains to small v-ditch directed toward rear yard of home. V-ditch extends below block wall, running through rear / side yard to street.

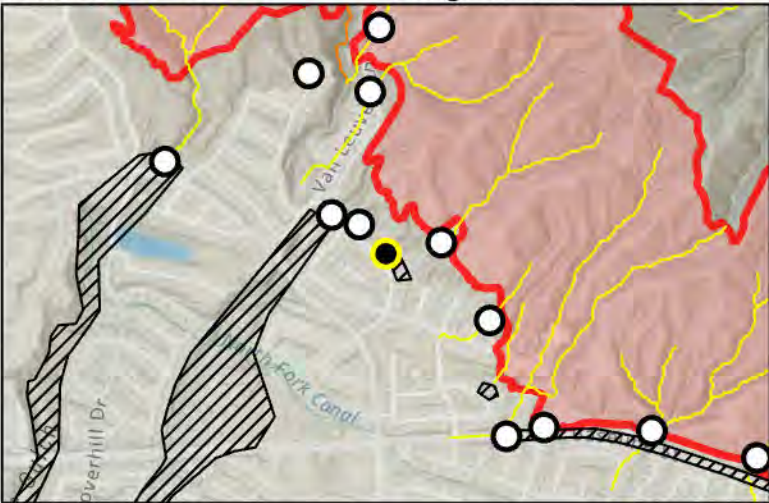
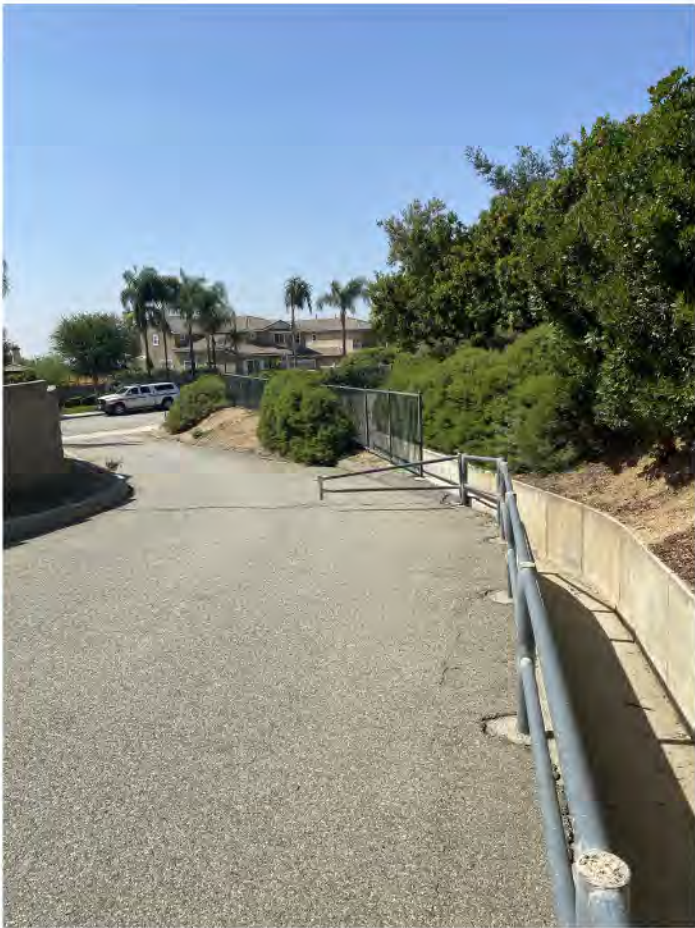
**Field Observation or** Pleasant View Lane adjacent to drainage inlet structure and water tank access road. Potential hazard is  
**Potential Hazard:** nuisance, sediment-laden flood flows down the water tank access road and across and down Pleasant View Lane.  
Potential for inlet to plug up, leading to backwater effects that will contribute to runoff down access road toward public street.

**Potential Hazard to Life: low**

**Potential Hazard to Property: low**

**Description:** Flow path is perceived to be unrestrained down water tank access road, with much of the runoff not being directed into adjacent drainage ditch. The inlet structure includes a 48-inch RCP drop structure with 6 ft freeboard so backwater effects are more likely than overtopping.
