# Watershed Emergency Response Team (WERT) 2024 Line Fire

CA-BDF-012520

November 6, 2024

**REPORT TITLE:** Watershed Emergency Response Team (WERT) Evaluation – 2024 Line Fire

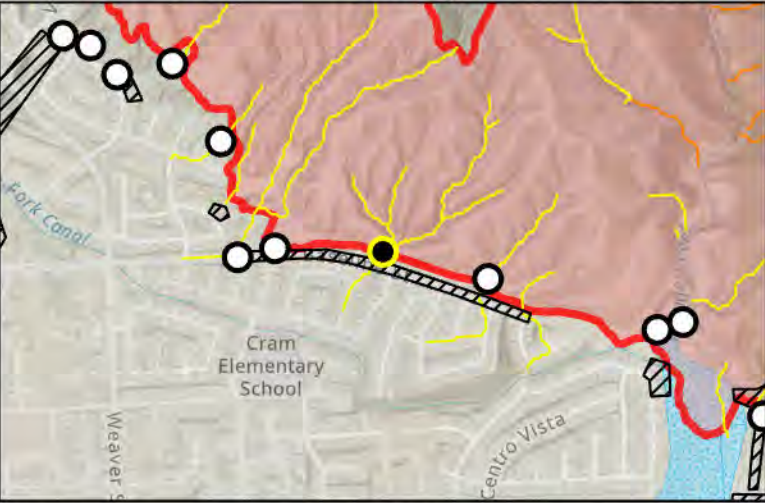
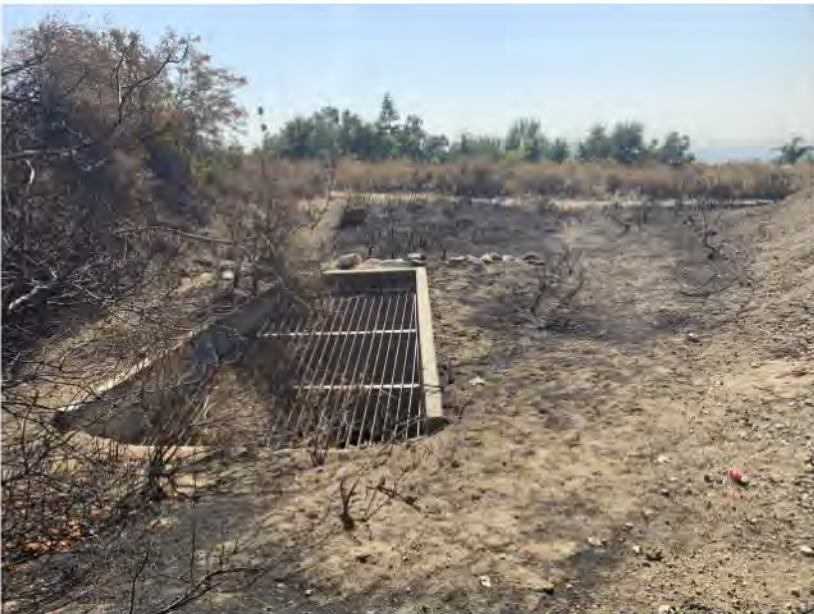
Latitude: 34.120937 Longitude: -117.151311

**Field Observation** or 48" diameter culvert that contains trash rack. Potential hazard is plugging of culvert resulting in flood flows that **Potential Hazard:** would be diverted onto Baseline Road.

**Potential Hazard to Life: low**

**Potential Hazard to Property: moderate**

**Description:** Not able to determine where culvert flows to, did not find outlet.

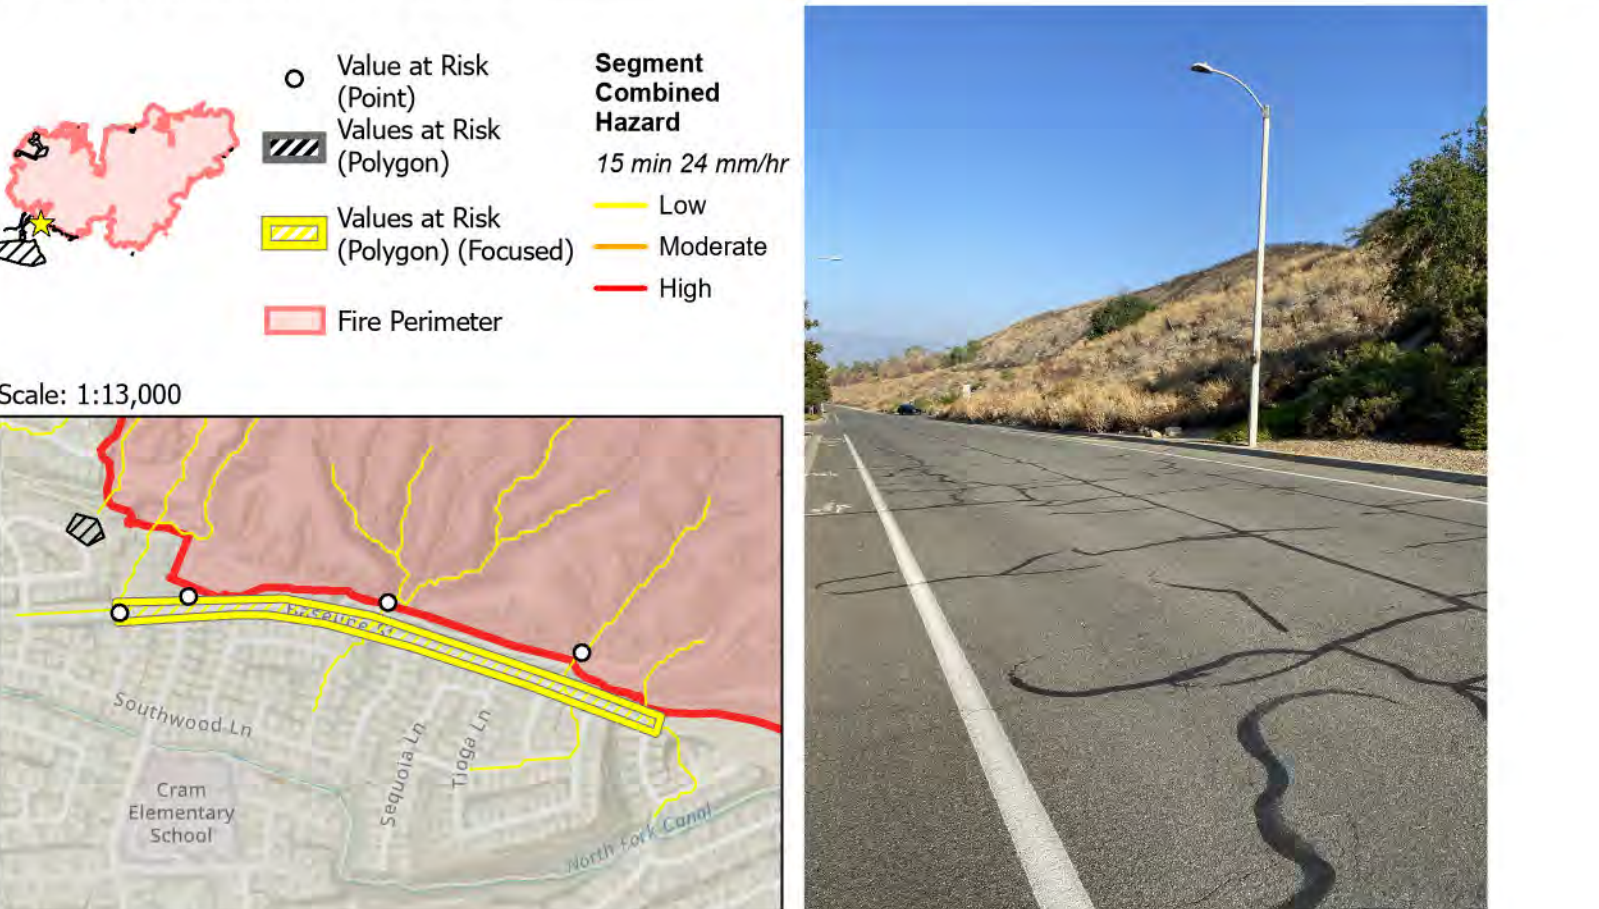
**Field Observation or Potential Hazard:** Portion of Baseline Road along slope toe with upslope burned drainages. Potential hazard is nuisance flood and sediment-laden flows over road surface as a result of multiple drainages that exit mountain front and direct runoff toward roadway.

**Potential Hazard to Life: low**

**Potential Hazard to Property: low**

**Description:** Flow path is unknown across manipulated terrain between road and drainage outlets.

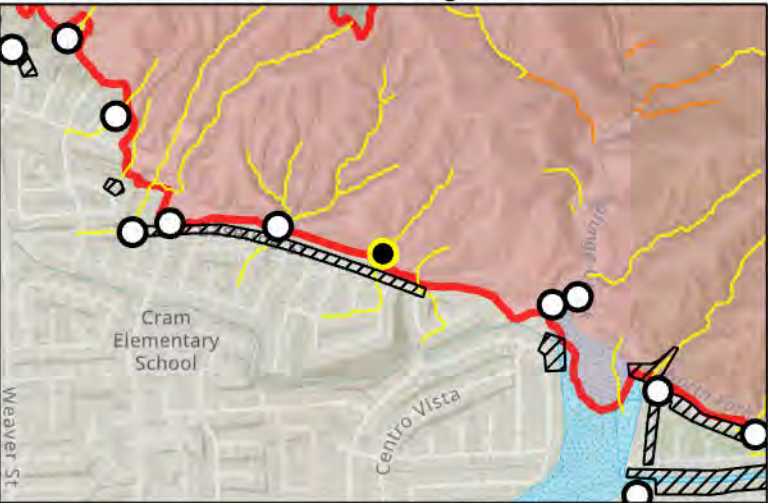
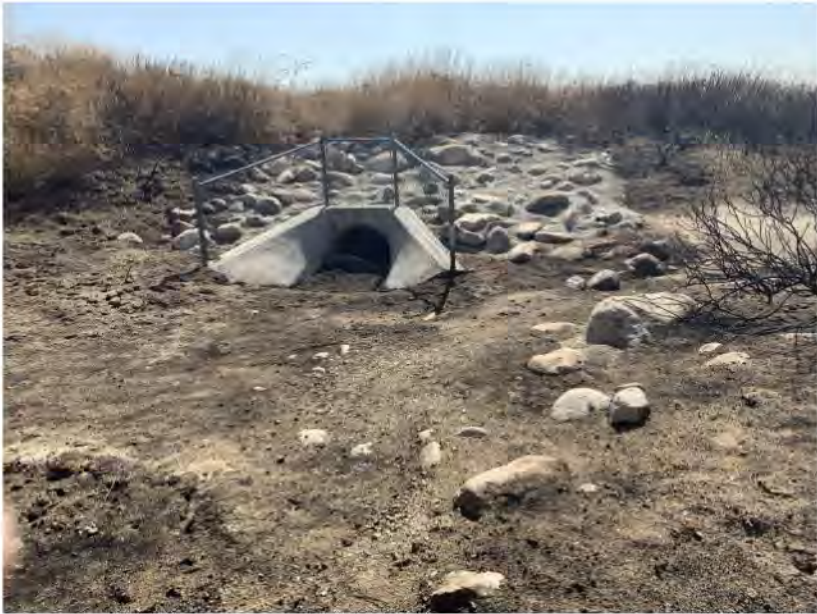
Latitude: 34.119992

**Field Observation or** 36" diameter culvert that contains trash rack. Potential hazard is plugging of culvert resulting in flood flows that  
**Potential Hazard:** would be diverted onto Baseline Road.

**Potential Hazard to Life: low**

**Potential Hazard to Property: moderate**

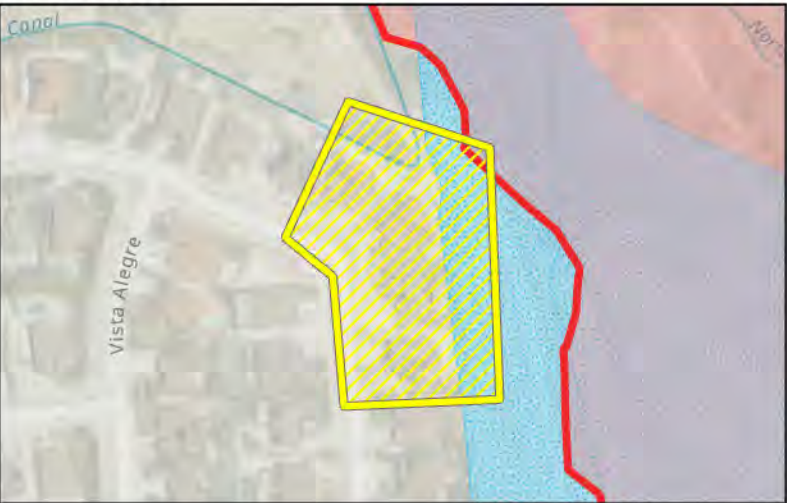
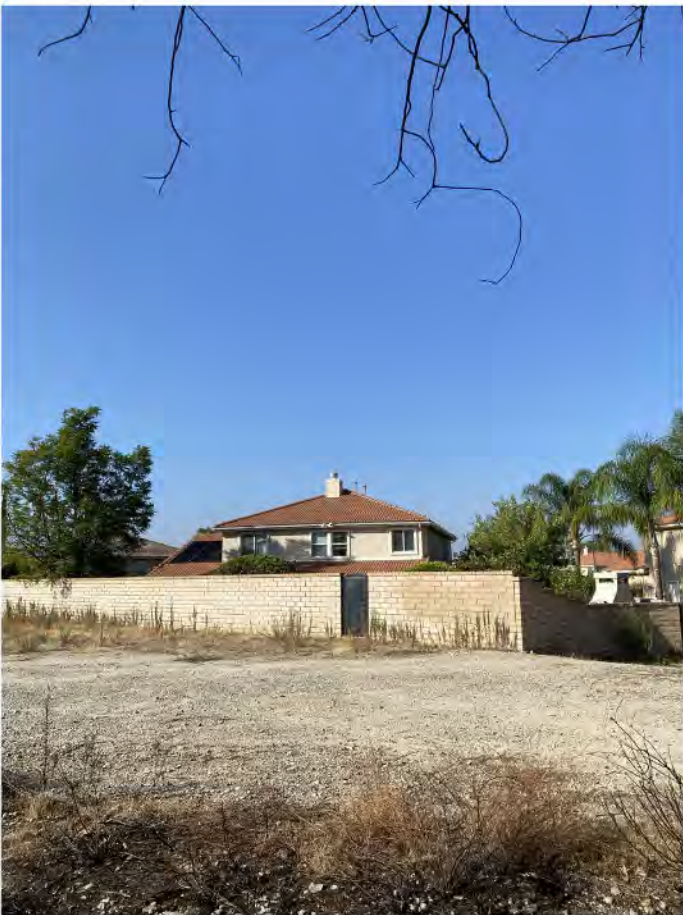
***Field Observation or*** Multiple residences located adjacent to watercourse. Potential hazard is debris flood / flow avulsing from  
***Potential Hazard:*** channel and impacting residences.

***Potential Hazard to Life: low***

***Potential Hazard to Property: low***

***Description:*** Spoke to homeowner at 7539 Vista Rio

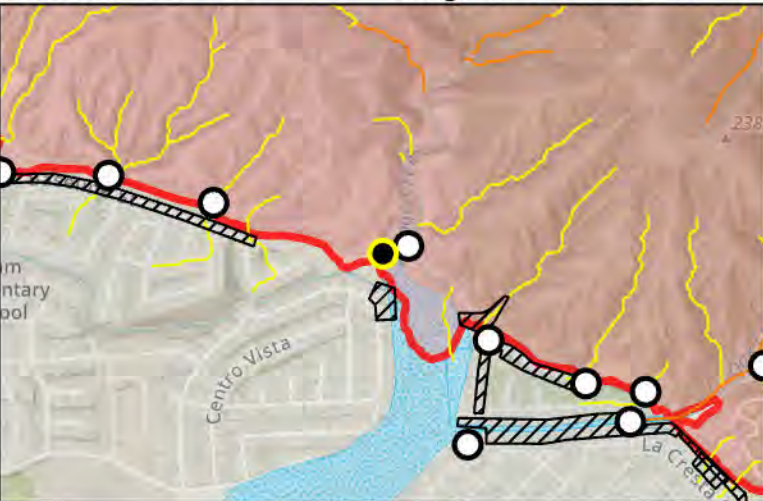
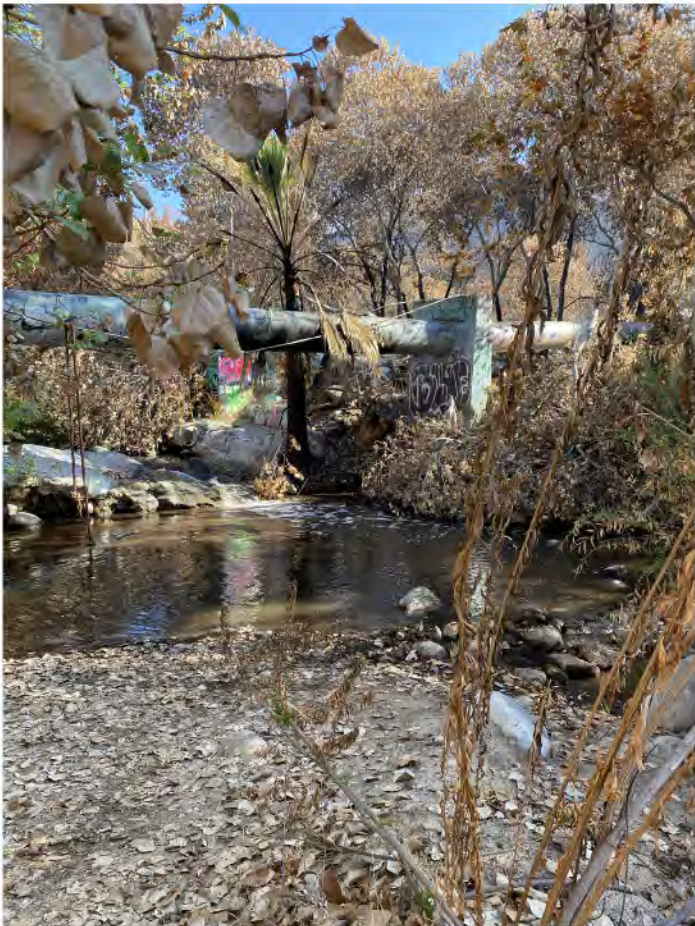
Latitude: 34.118262

**Field Observation or** North Fork Canal crossing over Plunge Creek supported on bents located adjacent to active channel. Potential  
**Potential Hazard:** hazard is debris flood / flow impacting canal (36" steel pipe supported on concrete bents).

**Potential Hazard to Life: low**

**Potential Hazard to Property: high**

**Description:** Upstream basin burned at low mod and high. Significant burnt woody debris and boulders that could become entrained.

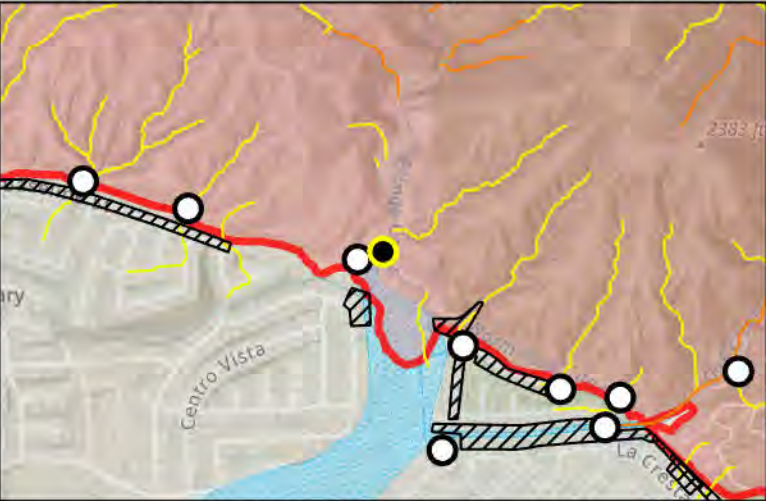
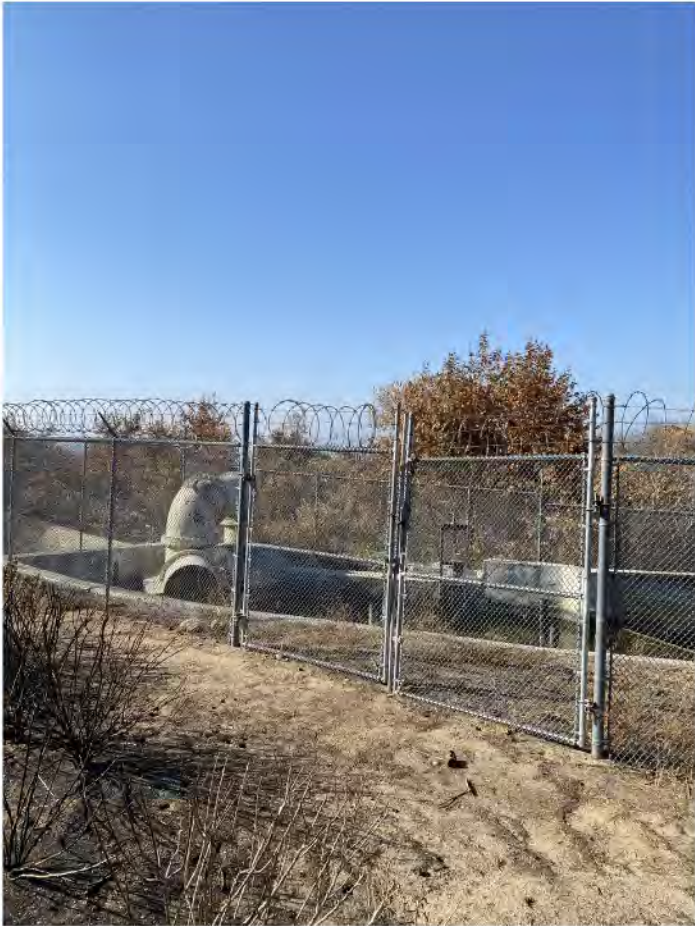
Latitude: 34.118441

**Field Observation or Water utility structure (siphon?) adjacent to watercourse. Potential hazard is debris flood / flow impacting Potential Hazard: structure.**

**Potential Hazard to Life: low**

**Potential Hazard to Property: moderate**

**Description:** Upstream basin burned at low mod and high. Significant burnt woody debris and boulders that could become entrained.

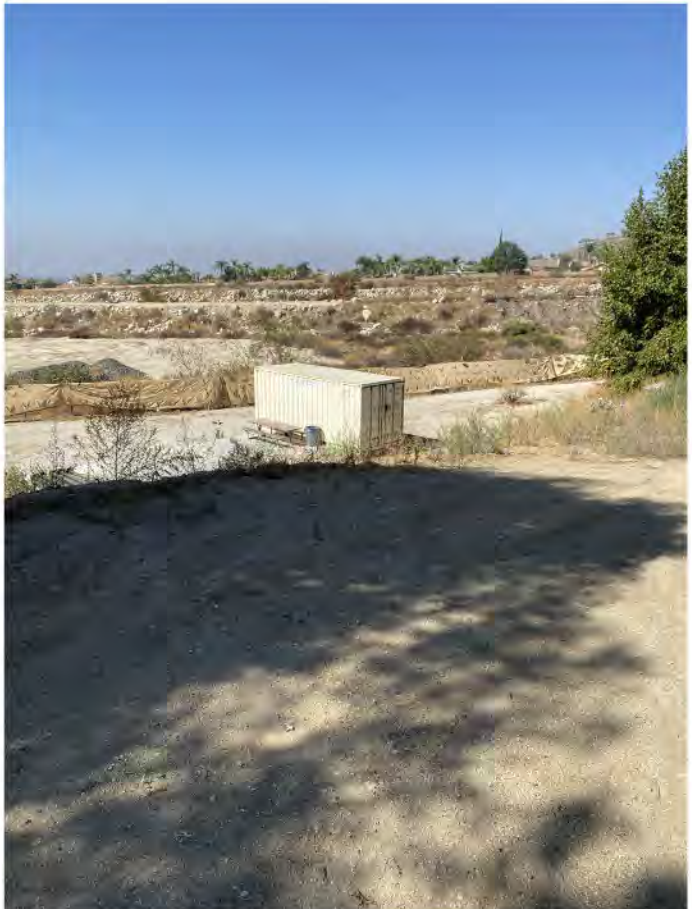
**Field Observation or Storage / junk yard situated within a drainage and at the outlet. Potential hazard is flood flow mobilizing debris**  
**Potential Hazard:** and materials and impacting on site storage containers.

**Potential Hazard to Life: low**

**Potential Hazard to Property: low**

**Description:** Potential to impact downstream residential street and property line wall.

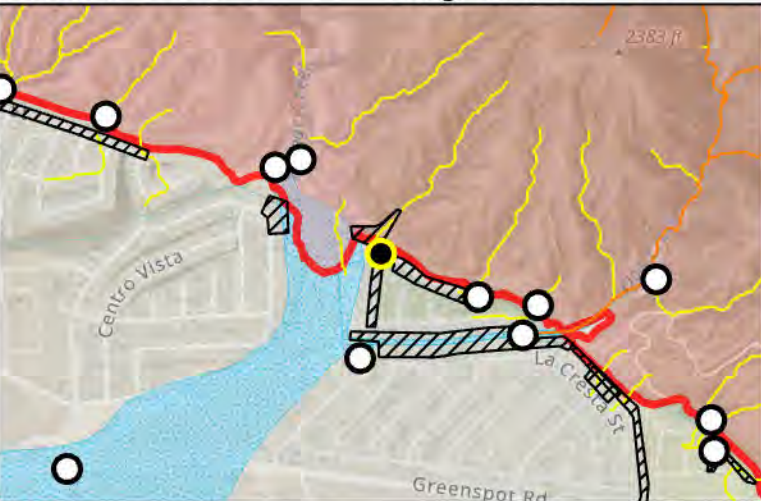
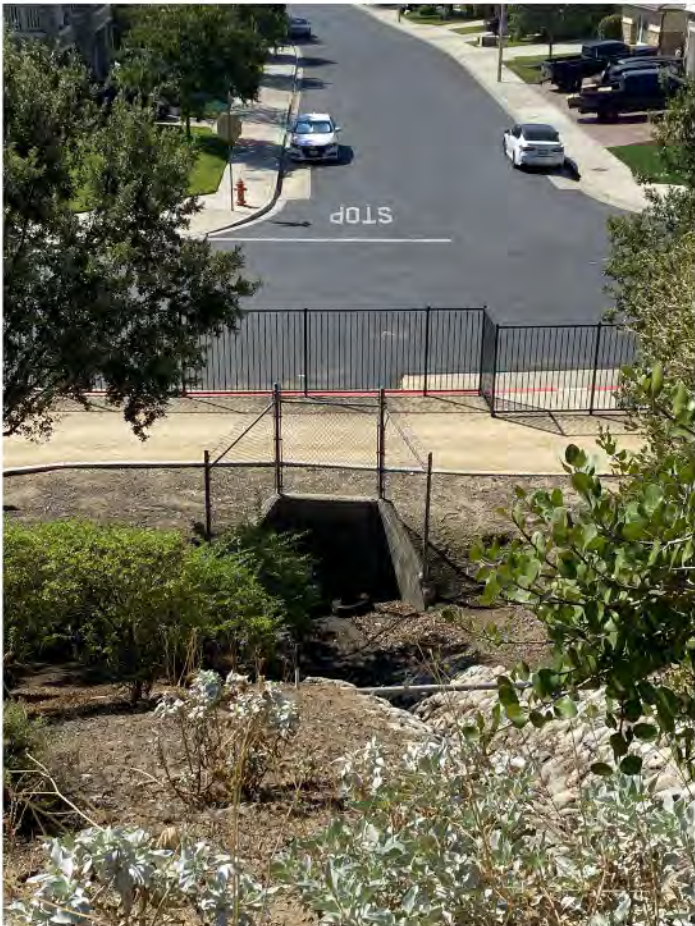
Latitude: 34.115627

**Field Observation or** Storm drain inlet adjacent to Cochrane Street. Potential hazard is clogging of inlet, resulting in overflowing  
**Potential Hazard:** flows spilling onto Cochrane Street.

**Potential Hazard to Life: low**

**Potential Hazard to Property: low**

**Description:** 36" RCP with flared wing walls at base of rock-lined v-ditch.

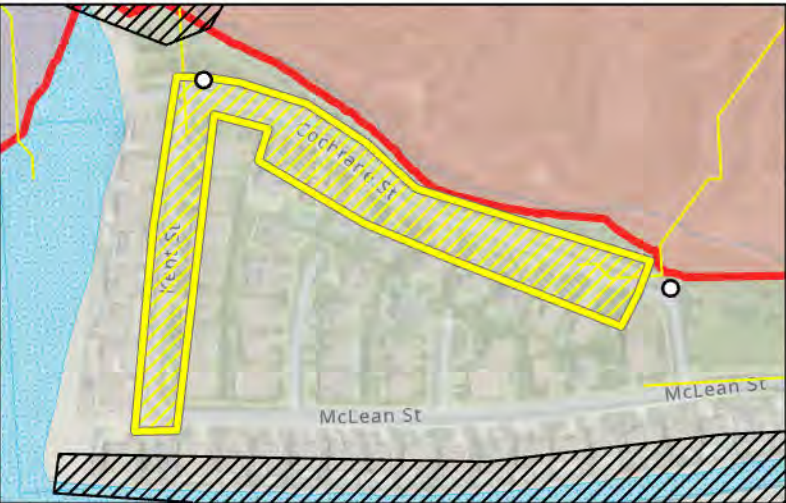
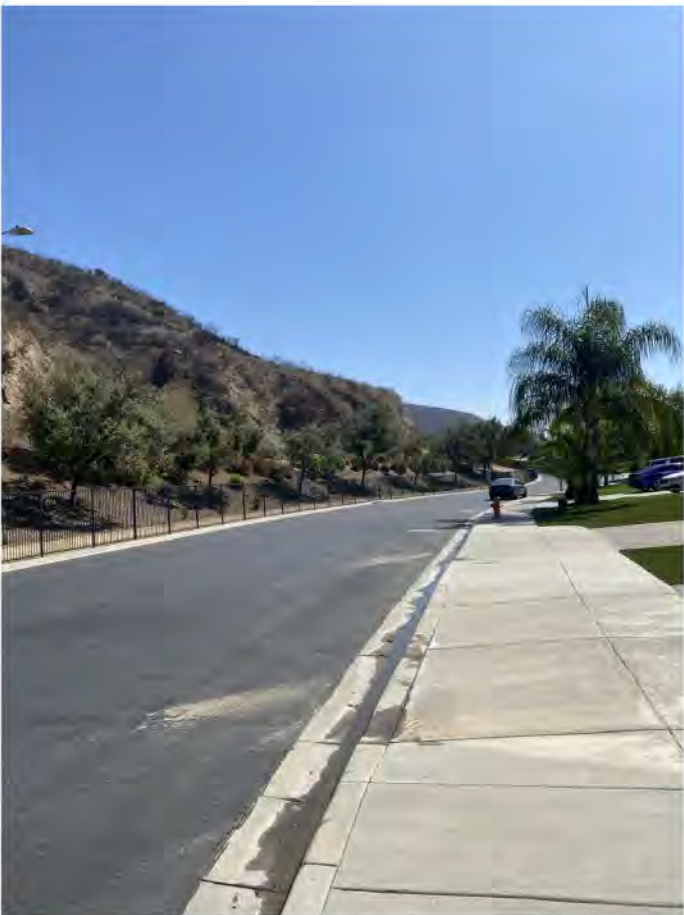
**Field Observation or Potential Hazard:** Kent Street and Cochrane Street located in potential flood flow path. Potential hazard is sediment-laden flows emanating from adjacent slopes onto Cochrane Street, with overland nuisance flow down Cochrane and Kent Street.

**Potential Hazard to Life: low**

**Potential Hazard to Property: moderate**

**Description:** Upstream drainages are relatively small, steep, and burned at low severity. Runoff is conveyed from drainage outlet to concrete brow ditches and rock-lined down drains that direct flows onto Cochrane.

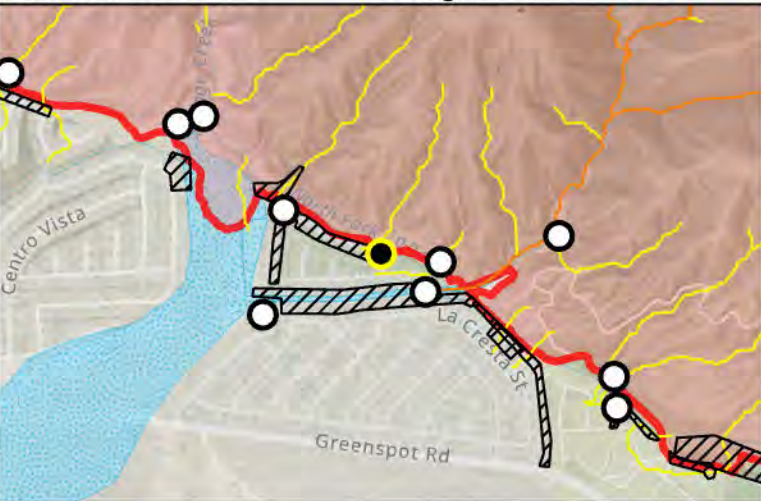
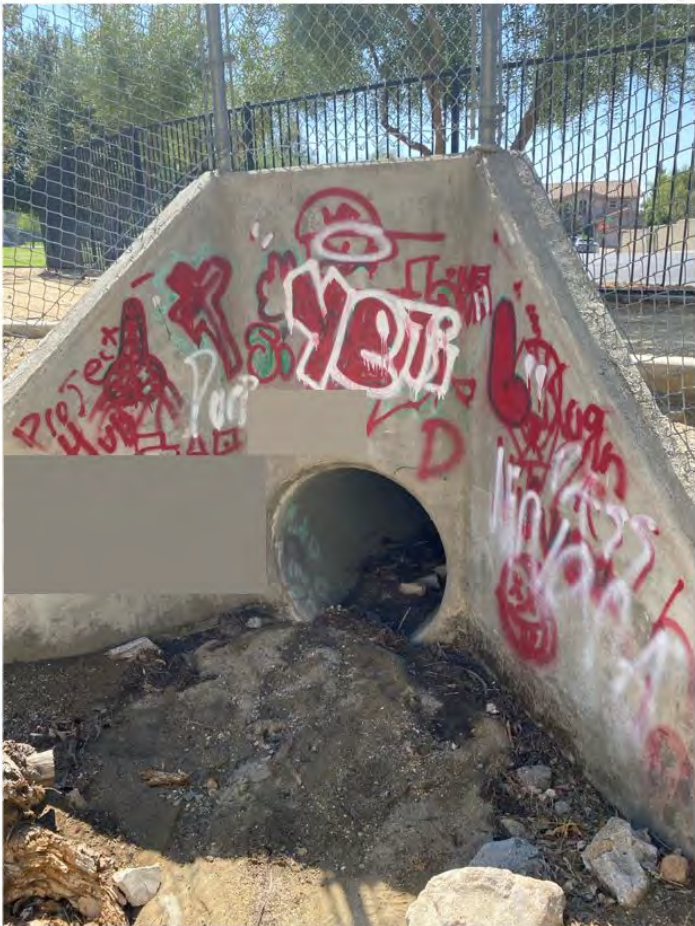
Latitude: 34.114232

**Field Observation or Storm drain inlet adjacent to Cochrane Street. Potential hazard is clogging of inlet, resulting in overtopping**  
**Potential Hazard:** flows spilling onto Cochrane Street.

**Potential Hazard to Life: low**

**Potential Hazard to Property: low**

**Description:** 36" RCP with flared wing walls at base of rock-lined v-ditch. Upslope contains a small debris basin and additional runoff routing devices.

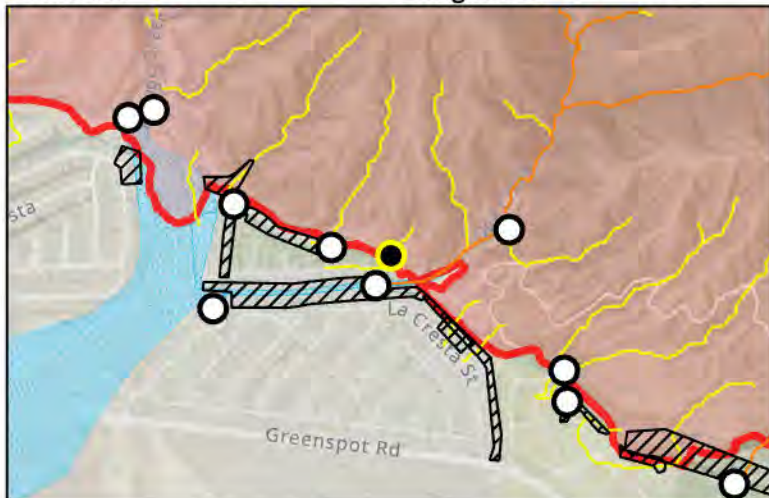
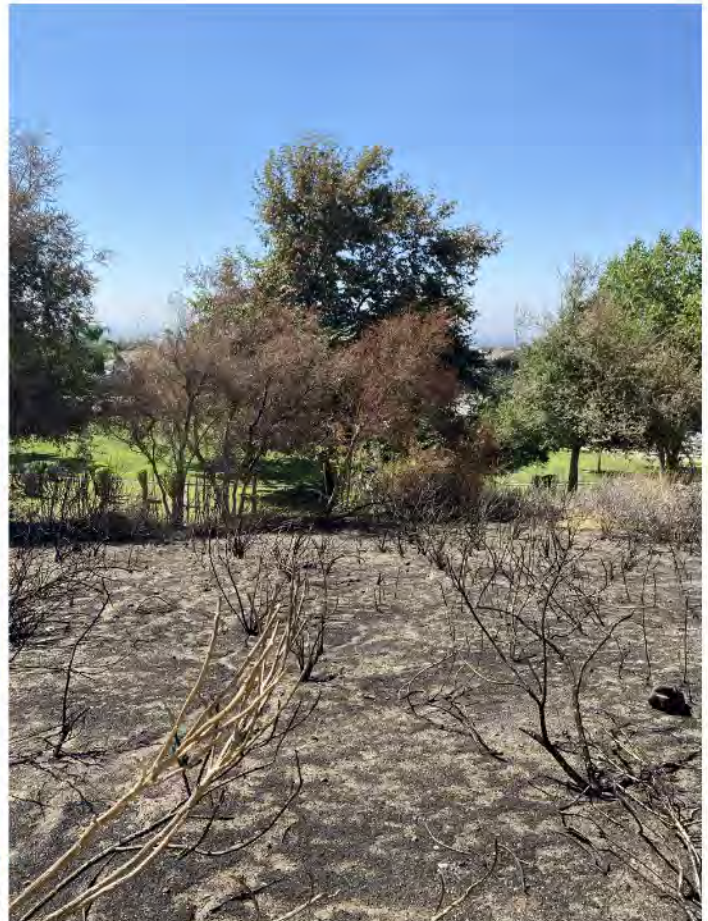
**Latitude: 34.113900**

**Field Observation or Community park located near outlet of steep drainage. Potential hazard is flood and mobilized burnt debris and Potential Hazard: sediment impacting park site.**

**Potential Hazard to Life: low**

**Potential Hazard to Property: low**

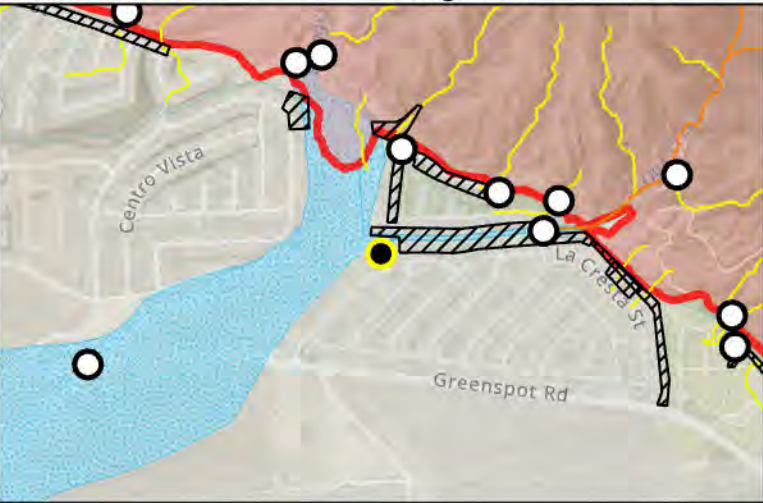
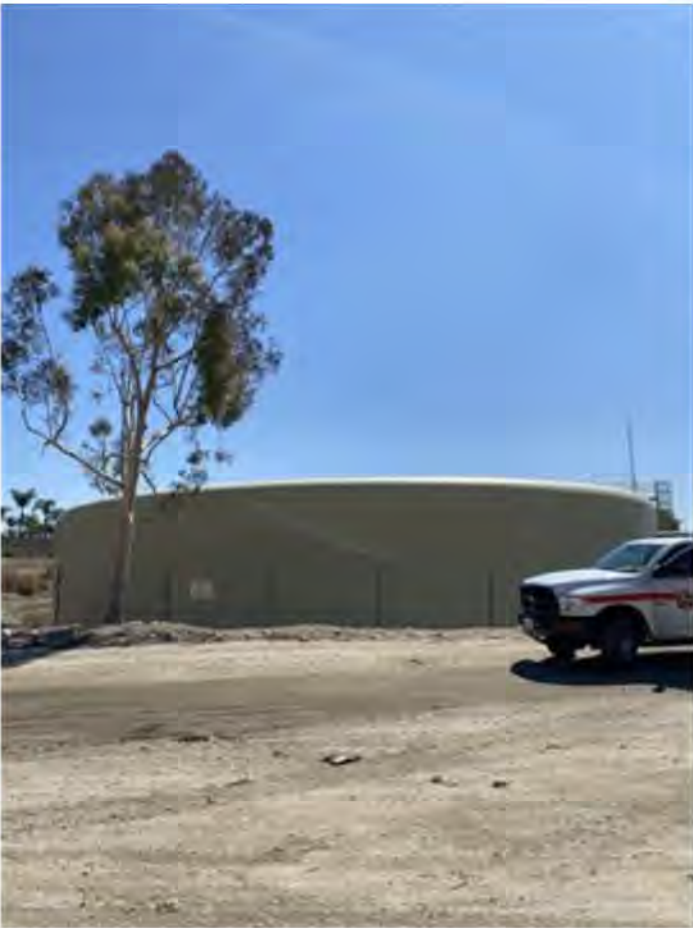
Latitude: 34.112686

**Field Observation or** Water storage tanks adjacent to Oak Creek controlled drainage channel. Potential hazard is debris flood / flow  
**Potential Hazard:** overtopping channel and inundating water tank site.

**Potential Hazard to Property: low**

**Description:** Upstream basin is moderately-sized and steep, and was burned at low and moderate severity. There is a debris basin upstream with debris racks on both ends. This basin could reach capacity during significant storm events or following back-to-back events.

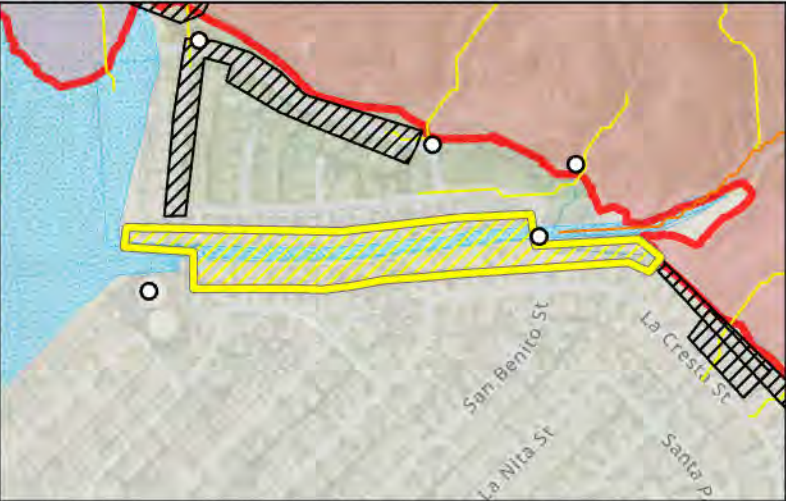
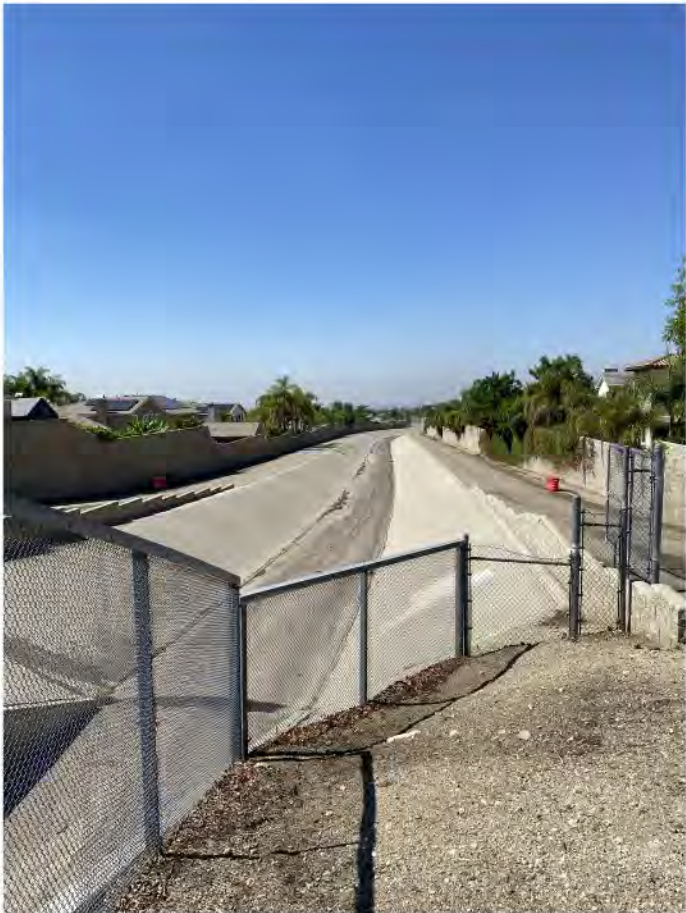
**Field Observation or** Multiple single-family residences adjacent to Oak Creek controlled drainage channel. Potential hazard is debris  
**Potential Hazard:** flood / flow overtopping banks and impacting rear block walls, inundating backyards and residences.

**Potential Hazard to Life:** **low**

**Potential Hazard to Property:** **moderate**

**Description:** Upstream basin is moderately-sized and steep, and was burned at low and moderate severity. There is a debris basin upstream with debris racks on both ends. This basin could reach capacity during significant storm events or following back-to-back events.

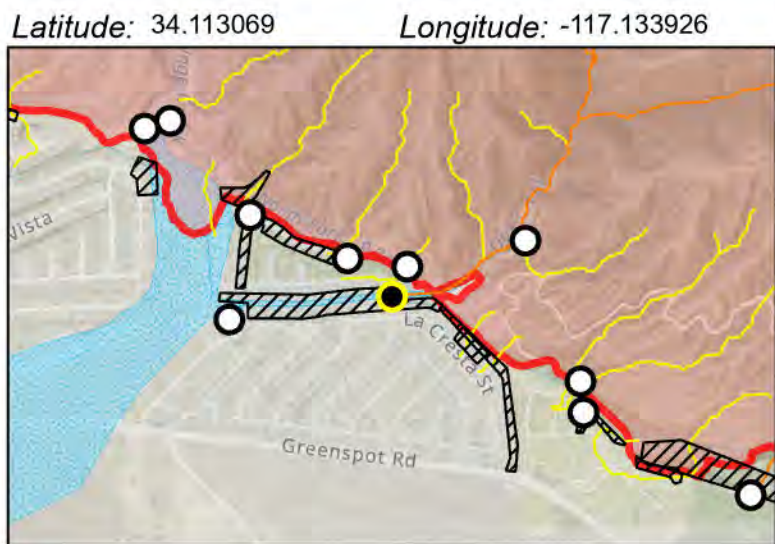
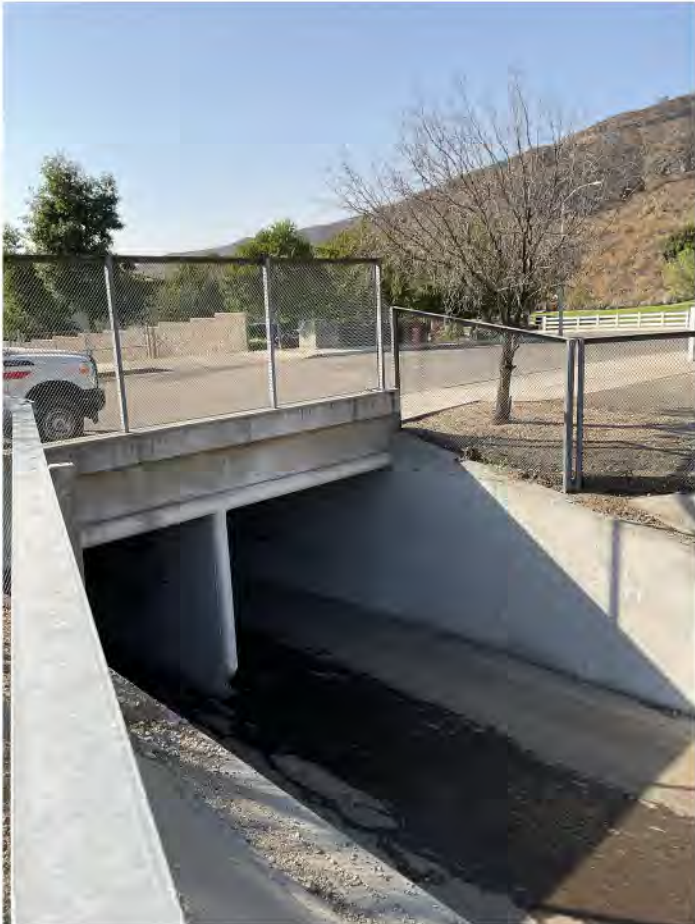
**Field Observation or** San Benito Street crossing over channelized portion of Oak Creek. Potential hazard is plugging of culvert  
**Potential Hazard:** crossing from debris flood / flow with overtopping flows and backwater effects impacting roads and structures.

**Potential Hazard to Property: moderate**

**Description:** Downstream of detention basin. Experienced very minor (inches) of flow during 9/20. Past flows reached channelized bankfull and plugged bridge. Post fire effects may elevate risk of overtopping roadway. Overtopping flows may divert into park to the north or into community south of the bridge.

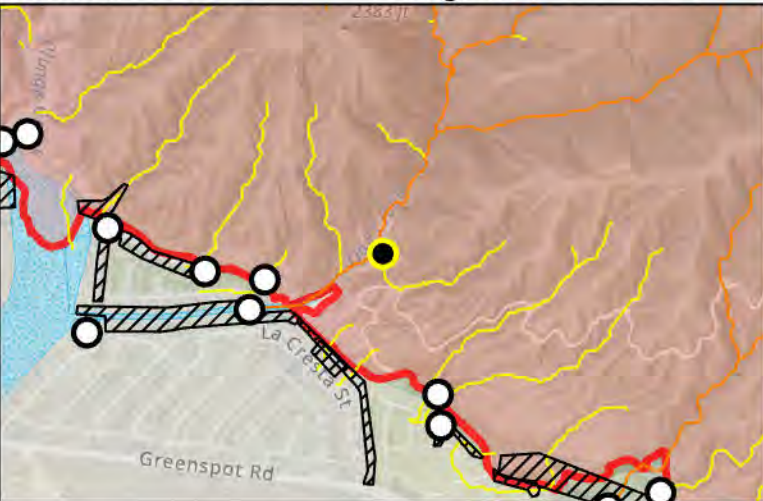
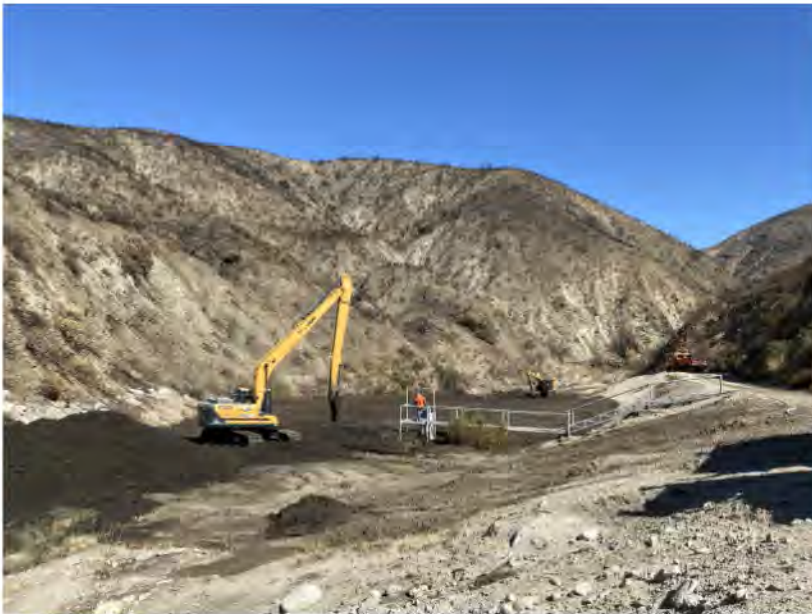
Field Observation or Debris basin with standpipe. Potential hazard is debris flow/flood filling and overtopping basin, resulting in  
Potential Hazard: increased flows downstream.

Potential Hazard to Property: **moderate**

Description: Debris basin experienced 12ft of deposition on 9/20. 5000+ cubic yards deposited. Trash racks above and downstream of basin.  
Future deposition and overtopping flows likely.

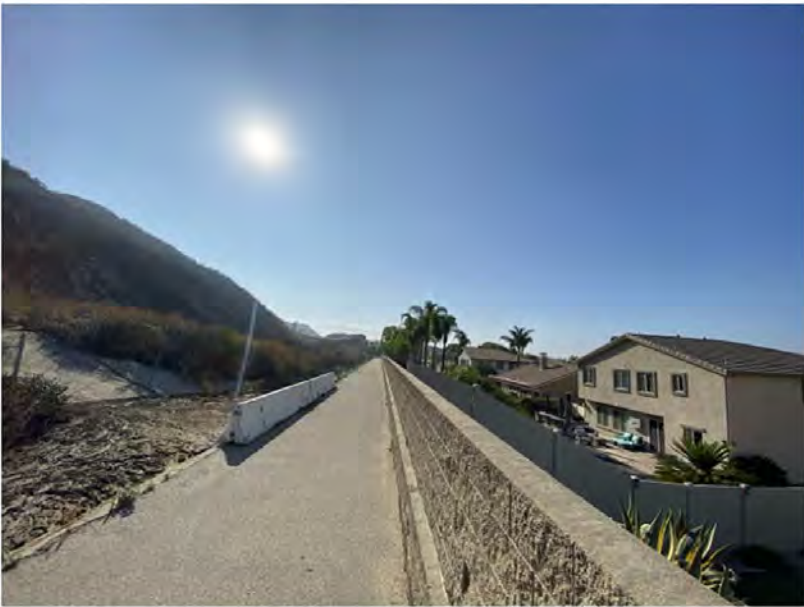
**Field Observation or Residence located at outlet of small drainage. Potential hazard is debris flow/flood overwhelming drainage ditch**  
**Potential Hazard:** and impacting multiple residences.

**Potential Hazard to Property: high**

**Description:** Small drainage burnt mostly at low. Highly altered upper drainage with multiple road crossings, fills, and small detention basins. Ditch is roughly 80% full. No debris basin observed at ditch. Loaded channel with boulders up to 2' diameter. Subsequent flows may mobilize boulders that may impact brick walls of residential yard. K-rails in place.

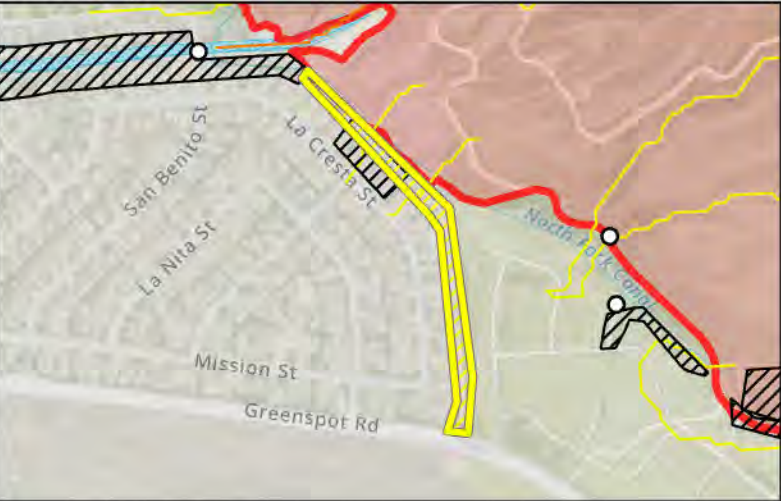
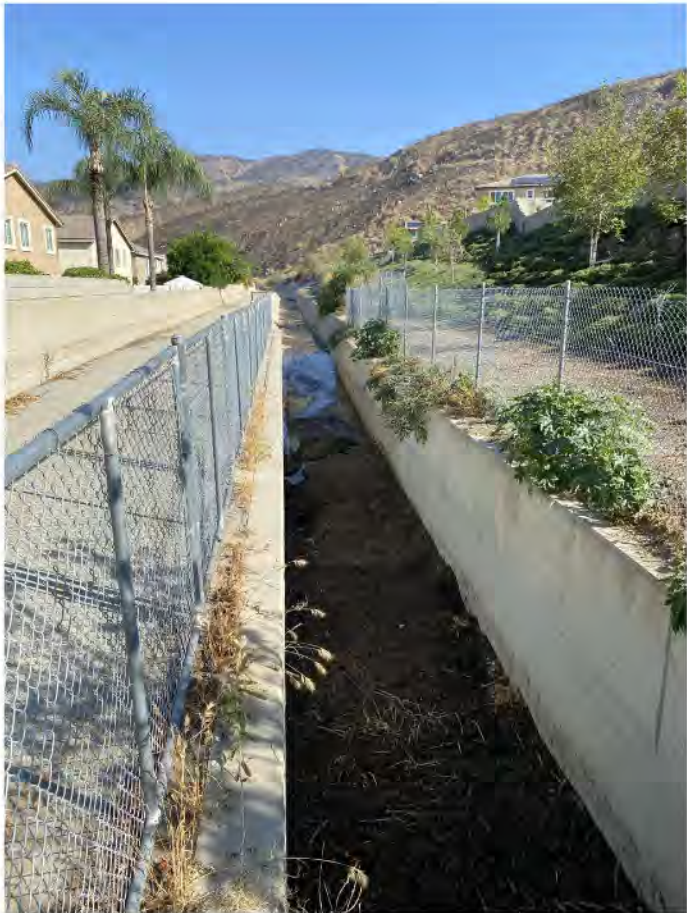
**Field Observation or** Drainage ditch located along service road and adjacent to residential back yards. Potential hazard is debris  
**Potential Hazard:** flow/flood avulsing from ditch and impacting homes and road surfaces.

**Potential Hazard to Property: moderate**

**Description:** Multiple mud deposits observed within and adjacent to the channel. Trash racks observed to effectively hold back debris. Service road adjacent ditch seems to also serve as secondary conveyance if ditch capacity is exceeded. Detention basin along south end of ditch system seems to have a vented culvert with a few feet of sediment deposition within CMP. Large flow event may exceed deposition capacity of this detention basin. Excess flow will likely deposit onto Greenspot Rd. which is the only eastern ingress/egress for the entire City of Highlands. V-ditch north of Marbella Way and down-slope of Alder Creek Rd will likely contribute flows into this v-ditch line. Dirt road (Alder Creek Rd.) upslope from ditch may serve as source area for debris. Home at 7855 La Cresta St, Highland, CA

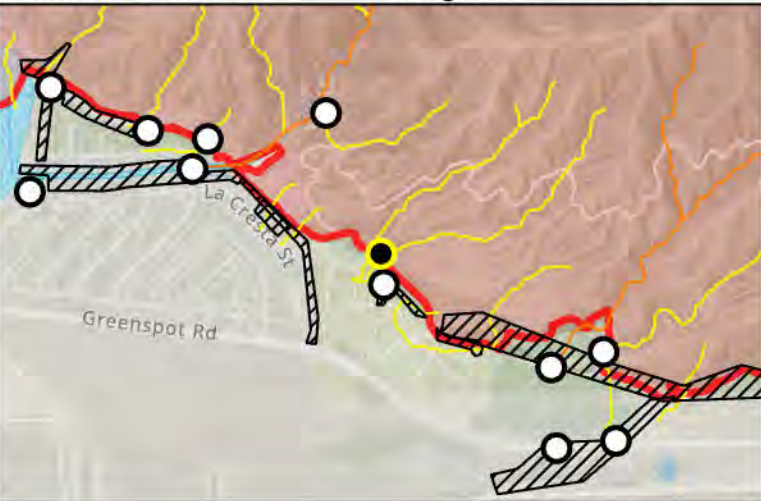
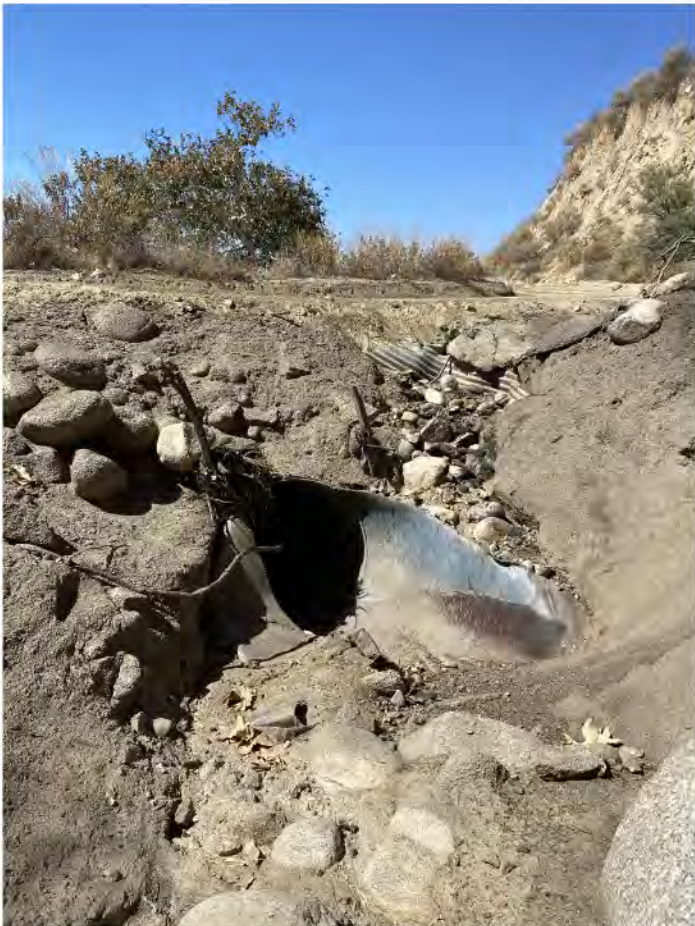
**Field Observation or Storm drain inlet adjacent to roadway. Potential hazard is plugging of the inlet with debris and overtopping road.**  
**Potential Hazard:** Impacts to downstream storm drain also expected.

**Potential Hazard to Property: moderate**

**Description:** Storm drain inlet that crosses beneath Alder Creek Road and presumed to enter storm drain system in downslope development. Debris flood / flow appears to have occurred here on 9/20/24, resulting in clogging of storm drain downstream, and debris flowing out of manhole riser onto access road and neighborhood street. Inlet is 48" CMP.

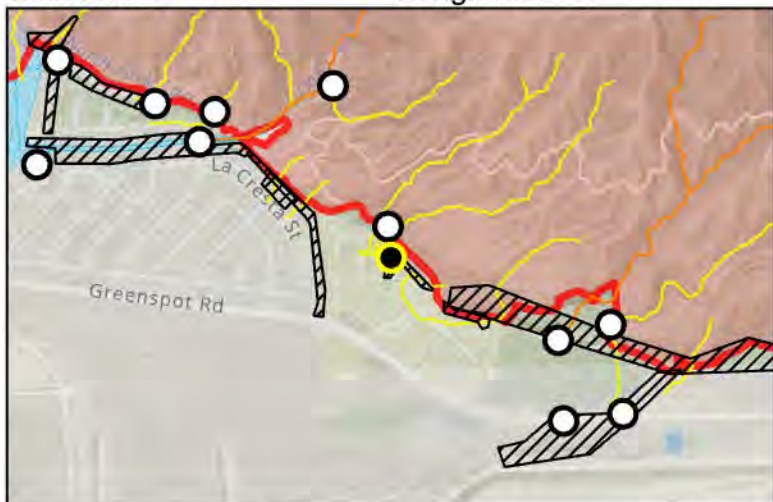
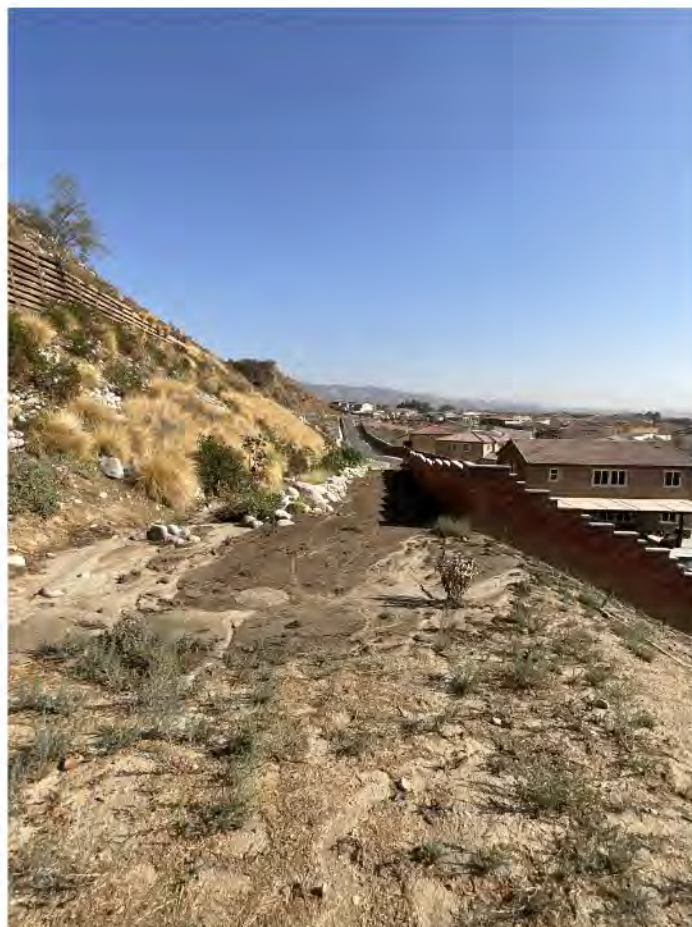
**Field Observation or Residence located adjacent to potential flow path. Potential hazard is debris flood/flow impacting residence and Potential Hazard: Ravello Court.**

**Potential Hazard to Property: moderate**

**Description:** Sediment-laden flow occurred during 9/20 storm event that spilled out of a storm drain manhole, down an access driveway and onto roadway and front yard at north end of cul-de-sac. Flow then progressed south along Ravello Ct. towards future development and Alder Creek Rd. Manhole likely delivered flow from LFV-37 that drains towards Marbella Way. Culvert at LFV-37 is believed to be tied-in to this manhole. Neighbor described flow as a "river," therefore flow was significant for an upwelling manhole. Possible compromised stormwater piping. Underground blockage likely. If this is repaired, larger flows may be diverted towards Marbella Way from LFV-37.

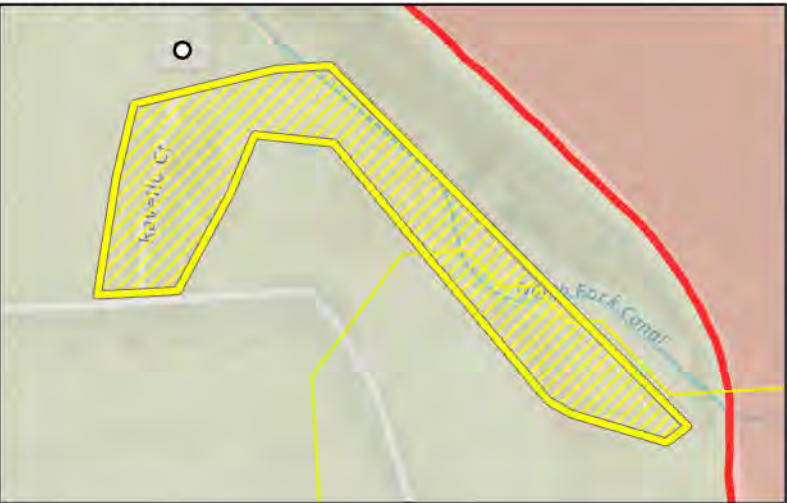
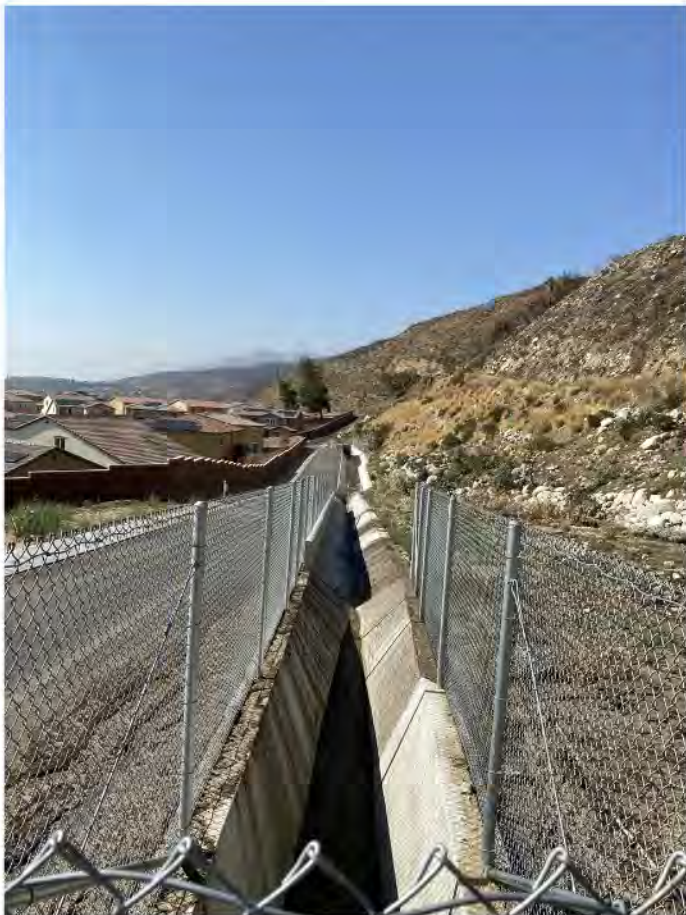
**Potential Hazard:** several residences. Potential hazard is filling and overtopping of ditch, and debris floods impacting block walls and homes.

**Potential Hazard to Property: low**

**Description:** Ditch likely to become plugged and overtop. Flow may then progress northwest towards block wall of backyards. Flows may then progress towards and deposit on Ravello Ct as it travels along the v-ditch service road. Discharge from upstream drainage splits into 3 segments. This VAR is a recipient of a majority of that discharge.
