# Watershed Emergency Response Team (WERT) 2024 Line Fire

CA-BDF-012520

November 6, 2024

**REPORT TITLE:** Watershed Emergency Response Team (WERT) Evaluation – 2024 Line Fire

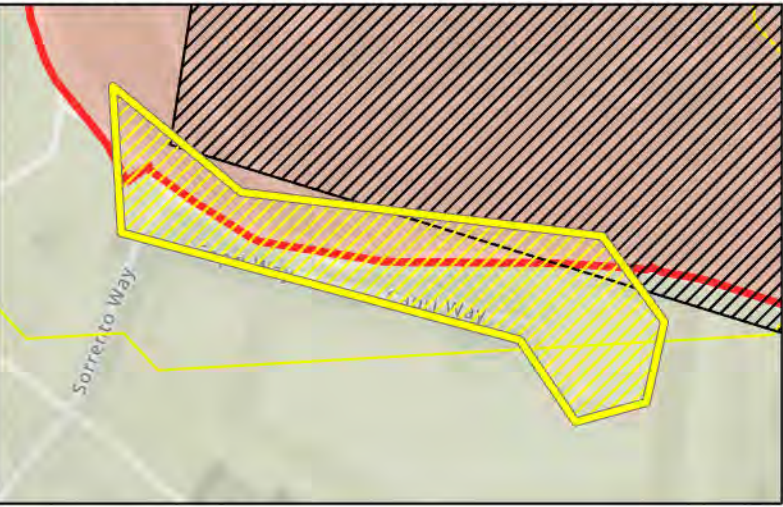
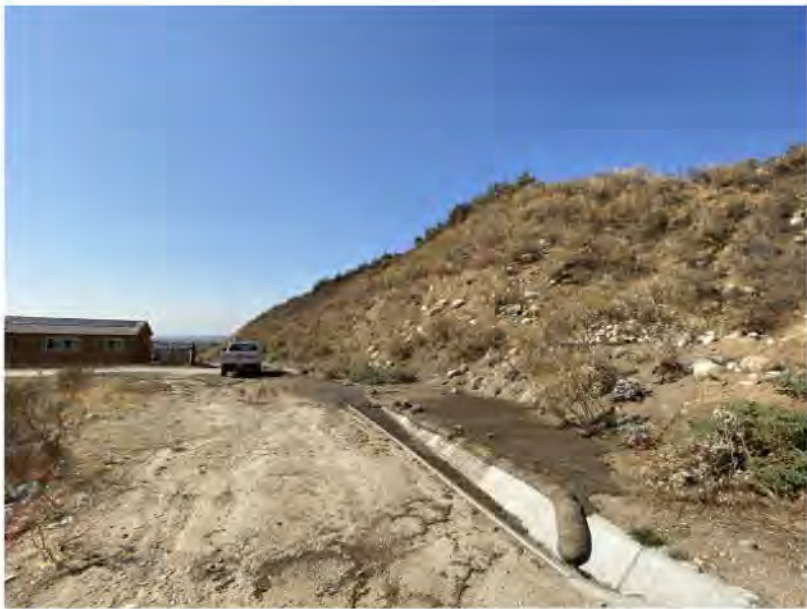
**Field Observation or Potential Hazard:** Two homes located adjacent to v-ditch and service road. Potential hazard is cobbles and debris may mobilize and proceed downgradient toward homes. If v-ditch conveyance capacity is exceeded, flows will deposit along roadway and impact homes.

**Potential Hazard to Property: moderate**

**Description:** Small drainage burnt at mostly low. Mountain front immediately upstream of VAR has been altered. Human activity diverted flows into 3 directions: southeast towards homes, south through orchard and down to road, and west toward LFV-39 and Alder Creek Rd. Man made rock revetments with loose cobbles observed at channel fork upstream of VAR. Capri Way serves as the only ingress/egress route for the cul-de-sac community.

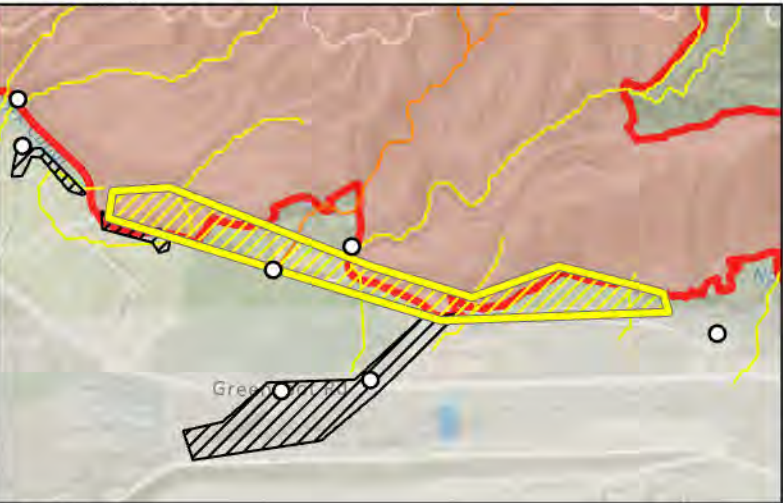
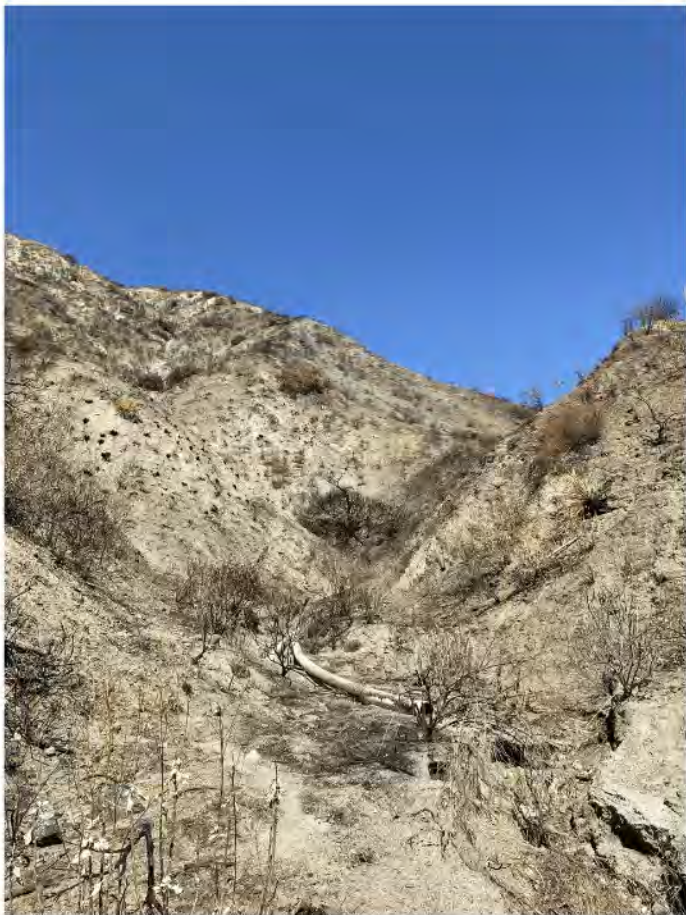
**Field Observation or** Orchards, agricultural equipment and damaged water infrastructure in / adjacent to potential flow paths of a  
**Potential Hazard:** minor drainage. Potential hazard is debris flow/flood impacting these features.

**Potential Hazard to Property: high**

**Description:** Water tanks and pumps are placed adjacent channel and will likely be impacted by flows. Orchards may experience debris and sediment from slopes. Slopes appear to be susceptible to rilling and gullying.

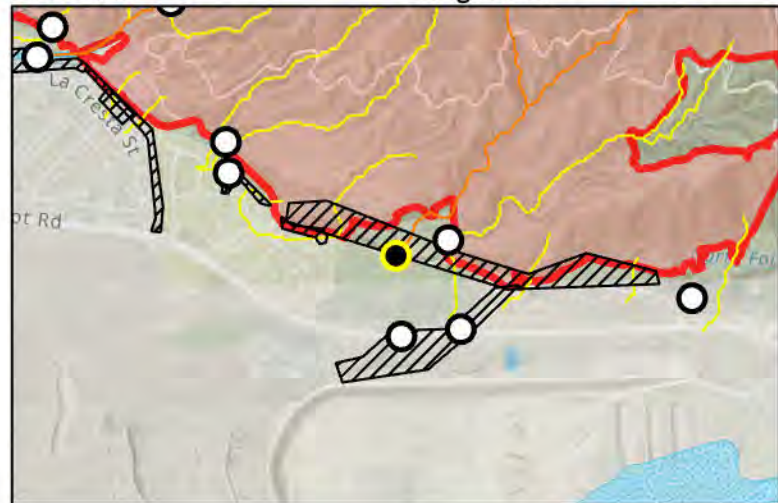
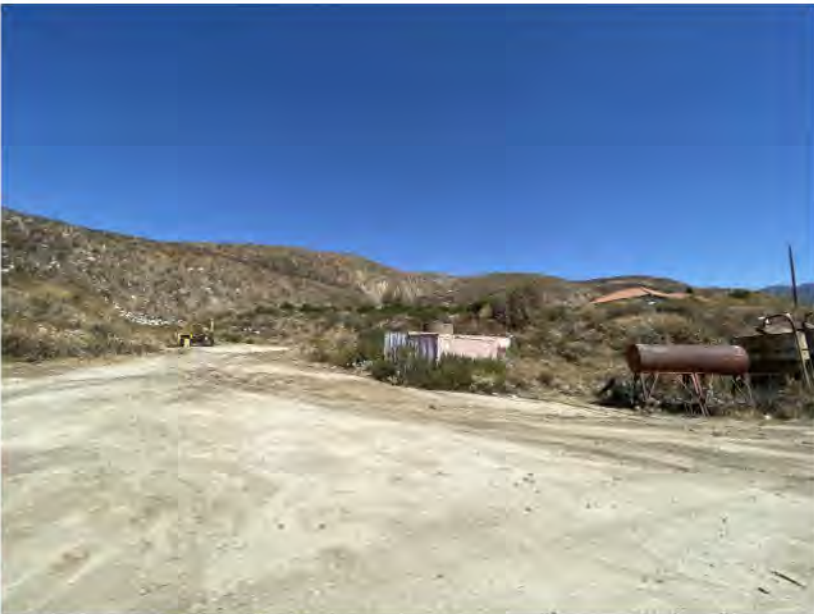
**Potential Hazard to Property: low**

**Description:** Alluvial fan located upstream and partially within orchard. Flows may impact a portion of orchard downstream of the fan. Equipment stored on fan may be impacted by flows. Flows more likely to progress towards LFV-43 as evidenced by 9/20 event.

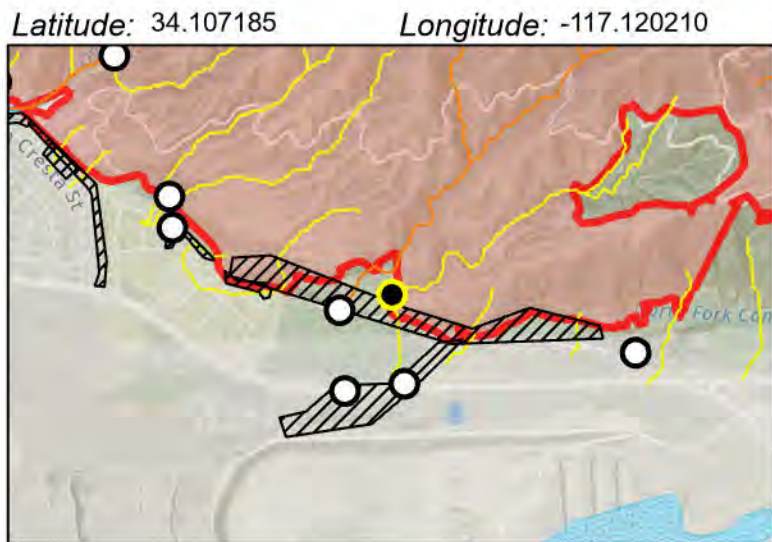
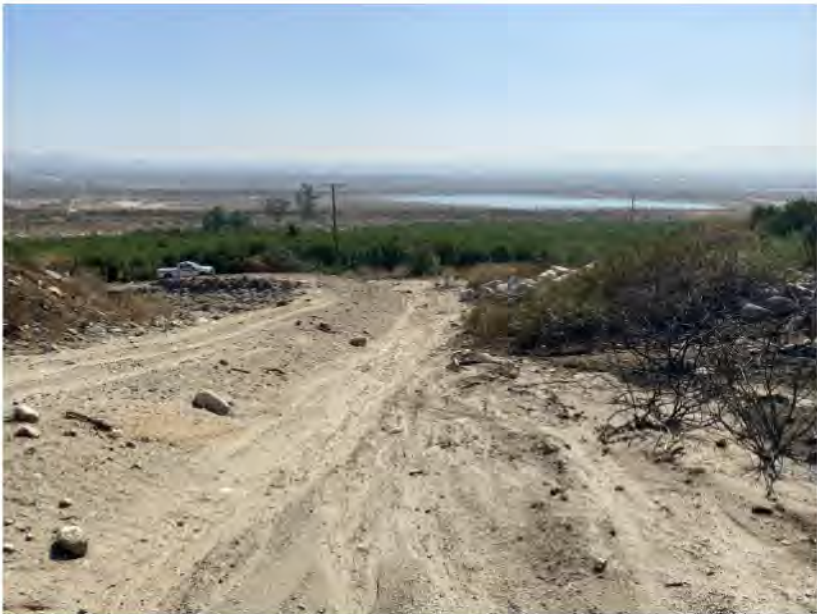
**Field Observation or** Debris flow/flood of private road and home  
**Potential Hazard:**

Possible probability of damage with moderate consequence = Intermediate risk.

**Potential Hazard to Property: moderate**

**Description:** Basin burned at mostly low. Farm home placed between drainages but 9/20 flows almost reached backyard after losing confinement. Future flows may lap against property, but unlikely due to rock revetment adjacent structure. Water tanks placed on what appears to be an upstream berm that protects the structure and diverts flows. Channel adjacent house is concrete and armored. Engineered channel walls act as berms to focus flow along northern boundary of property away from the home and orchards. Evidence of overbanking observed following 9/20 flows, particularly at the sharp 90-degree bend. Pipeline upstream and spanning channel.

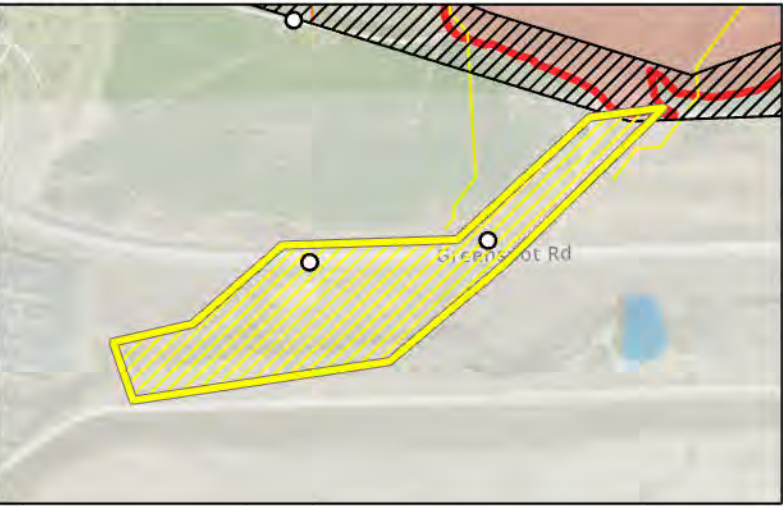
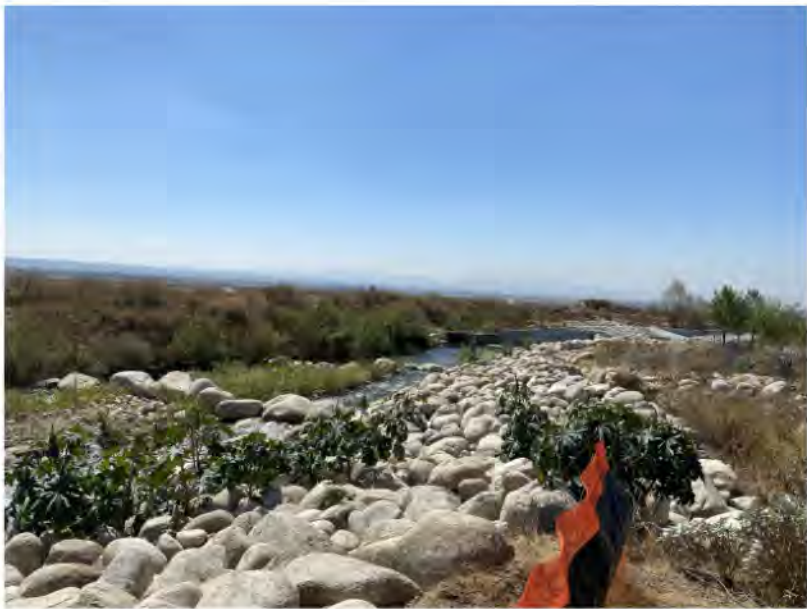
**Field Observation or** Debris flow/flood of roadways, culverts, and utilities  
**Potential Hazard:**

**Potential Hazard to Property: moderate**

**Description:** Flow likely to escape channel upstream of Greenspot Road. Flows likely to then re-enter channel after impacting culvert, inundating road, and flooding water facility south of the road. Flows may then impact gate and weir adjacent to East Valley Water District facility.

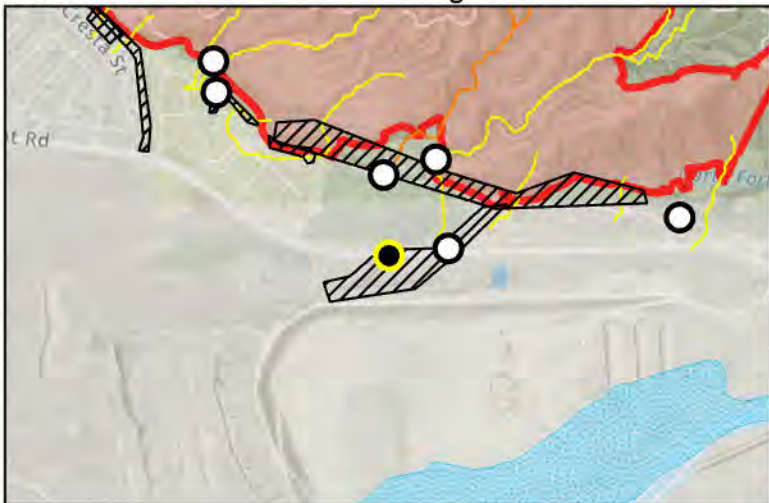
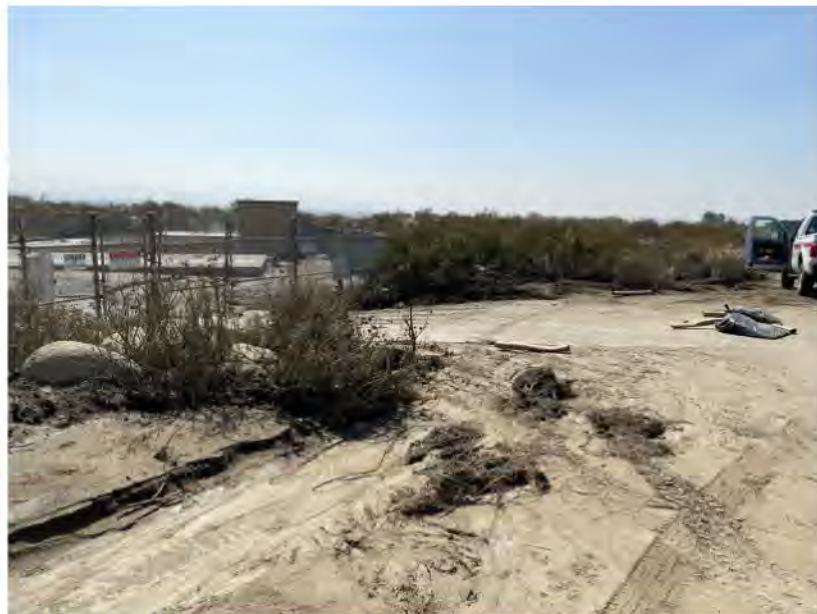
**Field Observation or Potential Hazard:** Flooding of water facility

**Potential Hazard to Property: moderate**

**Description:** Santa Ana low turnout fully buried in sediment. Plugged culvert downstream from farm diverted flows west along Greenspot Road into water facility. Basin was mostly low severity. Larger flow would likely deposit downstream of this facility and enter the adjacent channel.

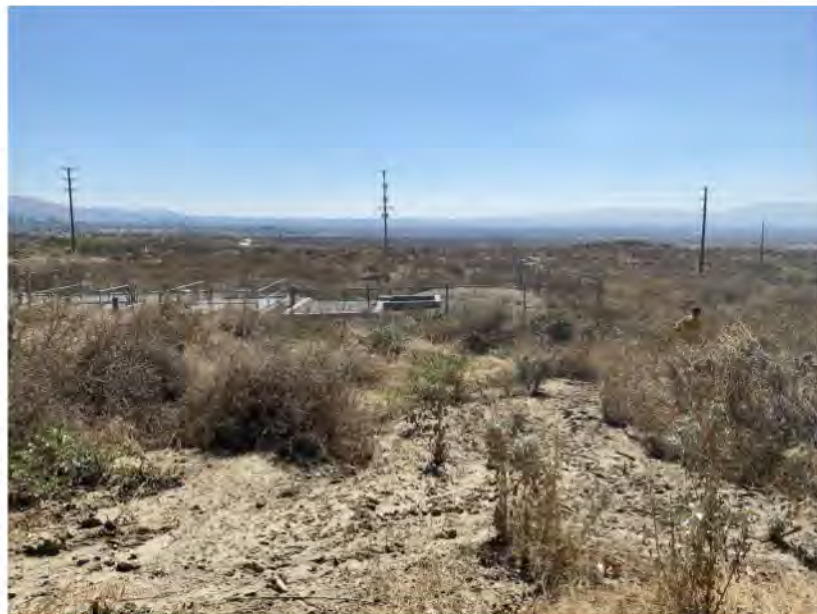
**Description:** Small drainage upstream burned at low. Deposits from 9/20 storm contacted edge of facility but no impacts observed. Plentiful debris on alluvial fan upstream of facility. Facility situated mid-fan. Larger flow may inundate the facility. 2 rock check dams that have been filled-in, where one has a plugged 12' boiler pipe culvert.

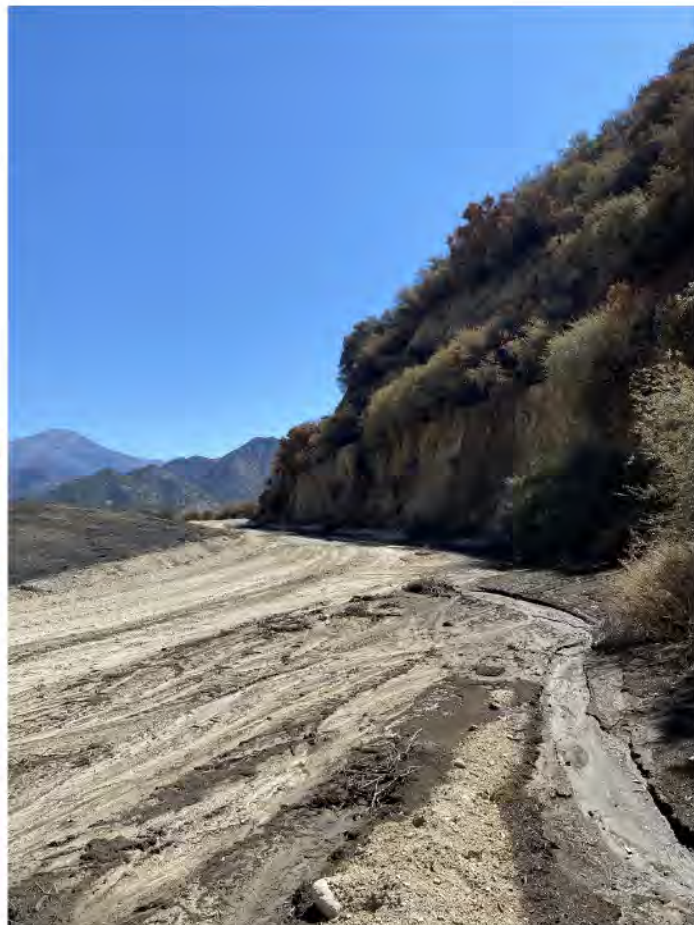
**Description:** Basin largely burned at moderate severity. Basin upslope of large, triple-benched fill with 5' deep vented culverts on downstream side. Fully clogged upstream culvert with very small 30'x30' basin. Sediment deposition along roadway. Entire road observed to have similar characteristics from a distance. High diversion potential throughout road. This was communicated to us as a CalFire road that is maintained by the county.

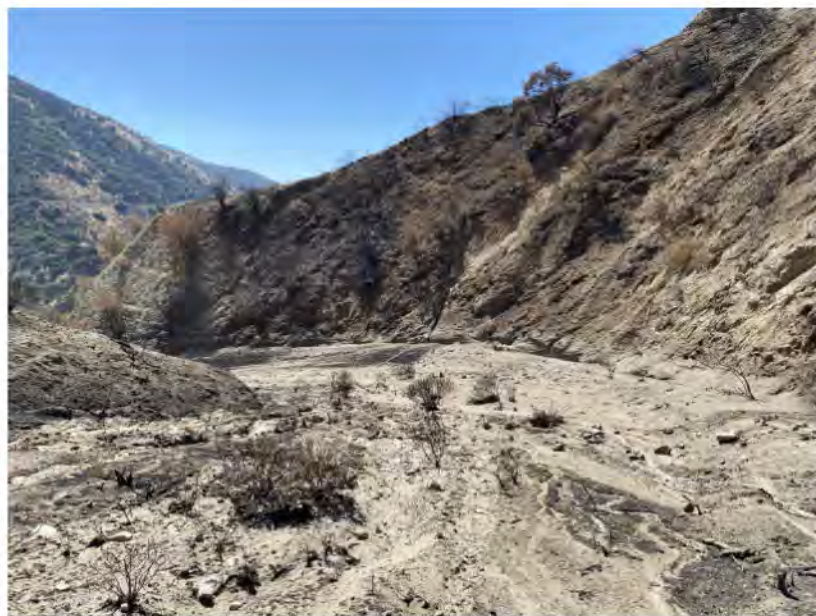
**Description:** Basin burned at roughly half moderate. Culvert crossing at road crossing likely blew out. Flow deposited cobble sized debris downstream and along roadway on 9/20. Flows tracked along roadway all the way to the bottom of the dam.

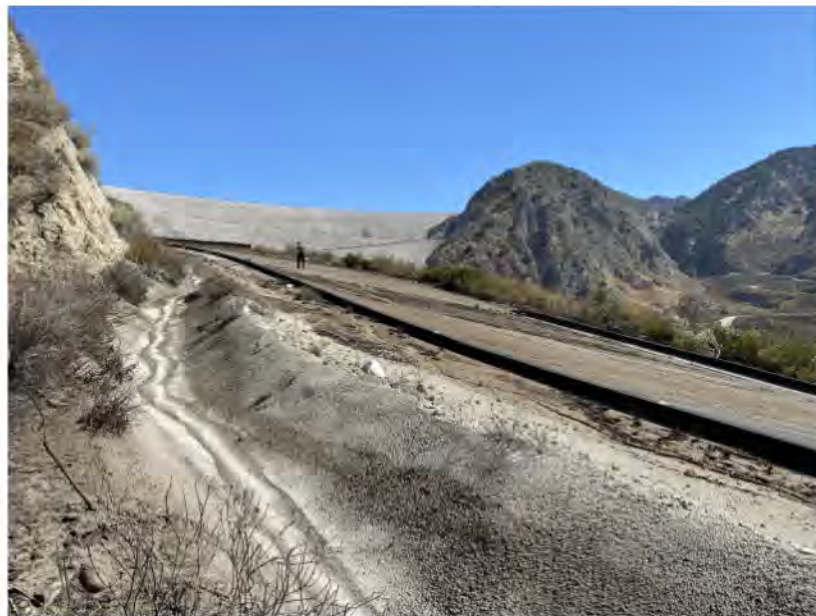
**Description:** Small basin burned at largely low severity. Half of basin unburned. 9/20 storm caused minor sediment laden flood onto roadway. 36" steel culvert with concrete headwalls. A portion of flow missed the culvert. The flow progressed down along the road, and due south off the road and down the engineered slope.

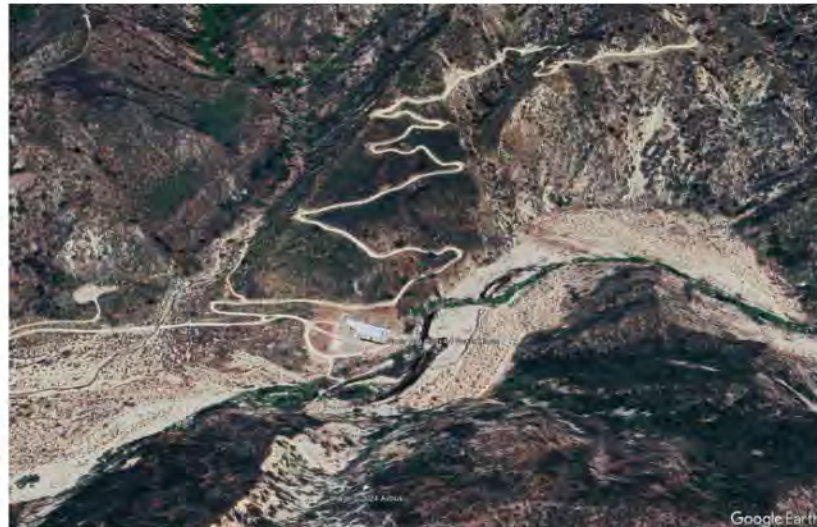
**Field Observation or** Hydro-electric station adjacent to the Santa Ana River. Potential hazard is debris flood / flow impacting  
**Potential Hazard:** structures.

**Description:** Assessed remotely. This site was inaccessible during the WERT field work. It is unknown if this facility is currently operating. Upslope basins burned at low, mod and high severity.

**Text:** Communicate hazard risk to So Cal Edison.

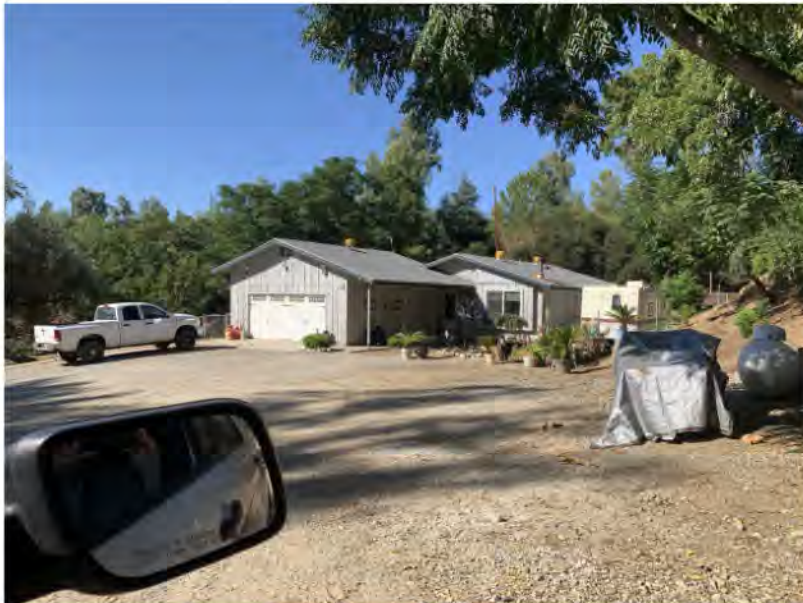
***Field Observation or*** Ranch, house, livestock located adjacent to watercourse and/or within potential flood path. Potential hazard is  
***Potential Hazard:*** debris flood overtopping or avulsing from channel and impacting home and structures.

***Description:*** Upper 25% of basin burned at low severity, while the rest was unburned.

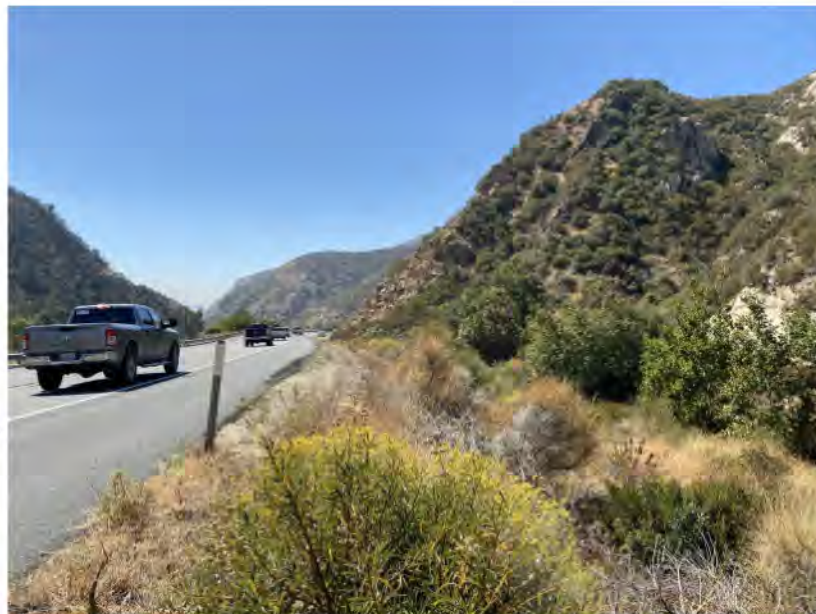
**Field Observation or Potential Hazard:** Culverted crossing below Mill Creek Road. Potential hazard is debris flow/flood impacting the crossing.

**Description:** Small upper tributaries burned at low and moderate. Substantial live vegetation in channel. Any flow would likely get attenuated. Large basin to retain debris due to culvert crossing acting as a dam. Road grade is roughly 50' above debris basin bottom. Unable to access culvert.

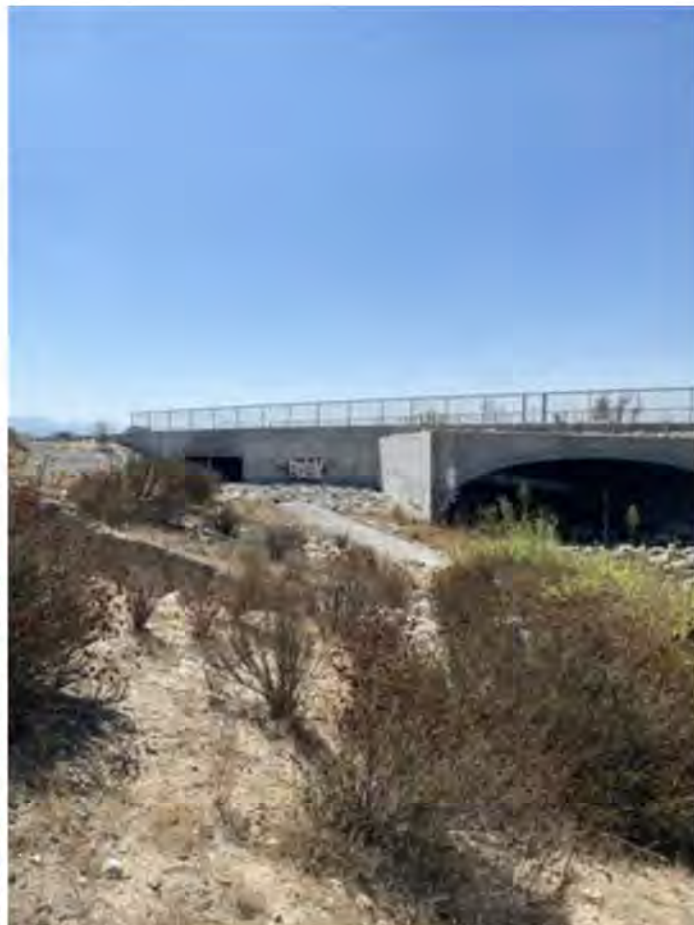
**Field Observation or City Creek culvert at Alabama St., just downstream of confluence with Plunge Creek. Potential hazard is flood**  
**Potential Hazard:** flow with entrained debris plugging all / portions of culverts, leading to backwater effects and inundation of adjacent areas.

**Description:** Crossing is a single structure with three components, including a double-barrel box culvert and two arch culverts. Source area burned predominantly at low severity, with some mod and high in the upper elevations.

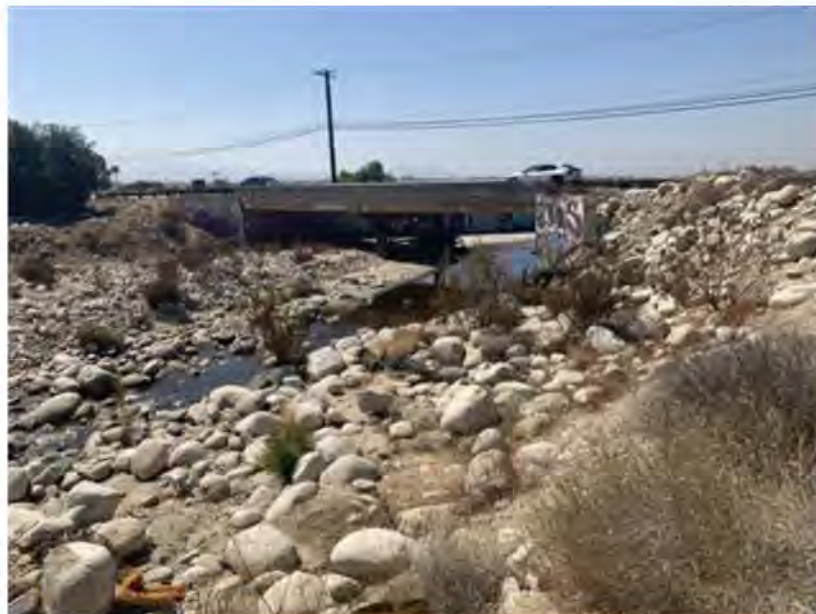
**Field Observation or** Orange Street bridge over Plunge Creek. Potential hazard is debris flow / flood impacts to bridge.

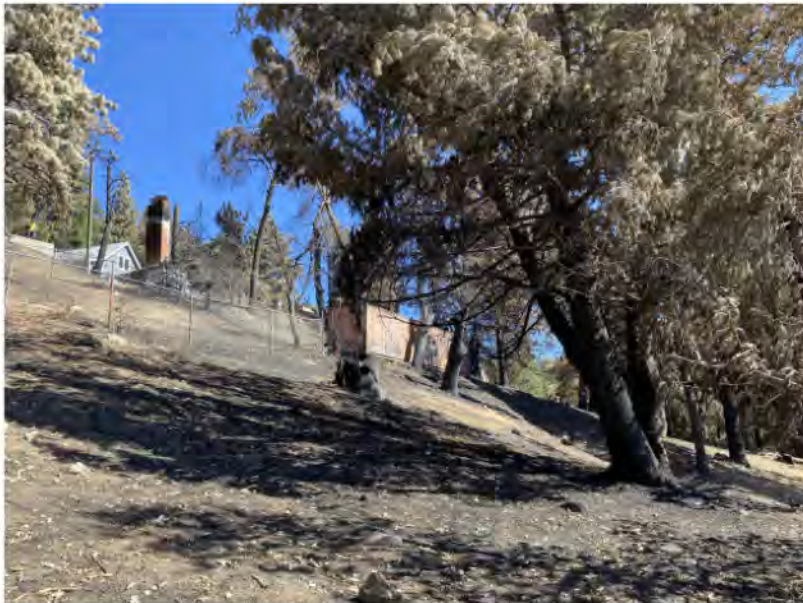
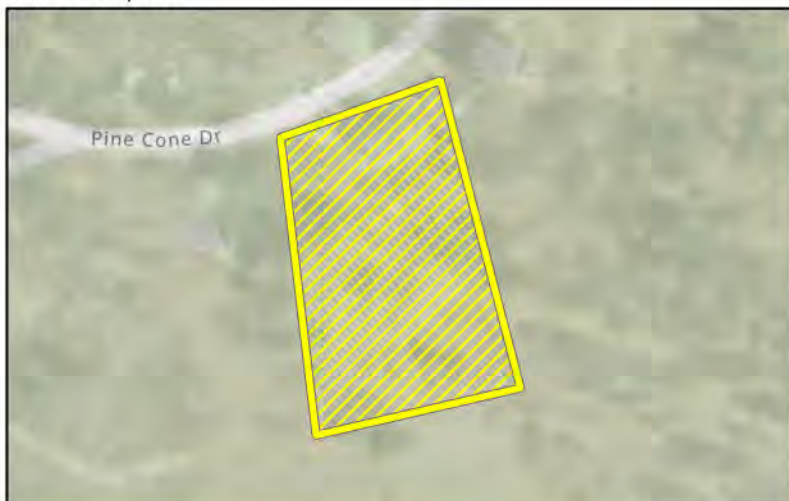
**Description:** Burnt slope immediately downstream of burnt structure. Low burn severity down gradient of home with loosened surface material. Loss of ground cover may intensify erosion immediately down gradient and adjacent of structure that may possibly cause subsequent failure. Evidence of soil creep along private dirt road below structure. High burn severity further down gradient. Moderately steep slopes (~25deg) below structure. Rilling and gullyng likely adjacent and near structure.

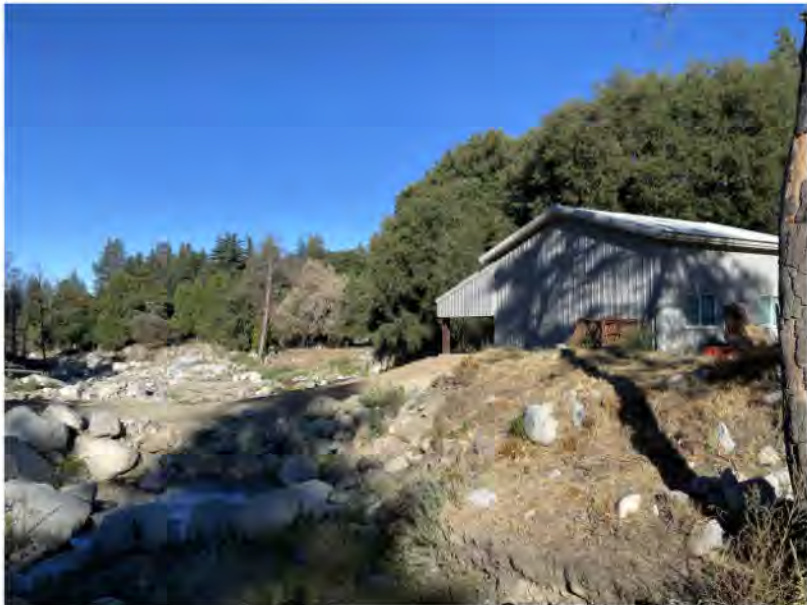
**Field Observation or Potential Hazard:** Barn structure and water well located adjacent to watercourse. Potential hazard is flood flows mobilizing debris and overtopping banks, resulting in inundation and impact to structures.

**Description:** The barn sustained minor damage from a debris flood that occurred during TS Hilary in August 2023. Since then, grading has been performed to infill the north side bank, which was significantly scoured out immediately adjacent to the barn. A porch has recently been added to the barn, with footings located where the scour occurred. A small portion of the upstream watershed burned at moderate and low severity within Mile Canyon, which may result in elevated flood hazard immediately downstream along the Santa Ana River. The residence at this location is more removed and elevated above watercourse (above high water from TS Hilary response).

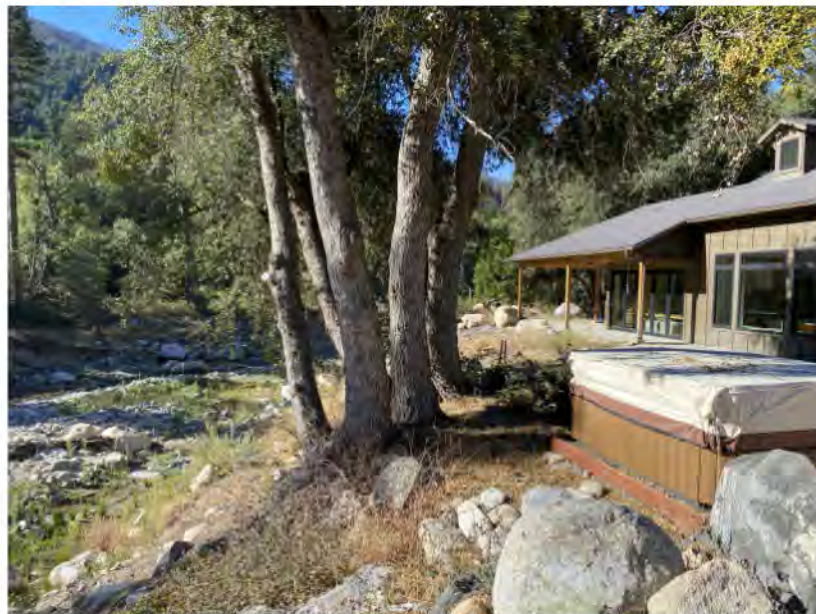
**Field Observation or Residence located adjacent to watercourse. Potential hazard is debris flood/flow overtopping bank and Potential Hazard: inundating residence.**

**Description:** Bank was scoured out during TS Hilary response resulting in near vertical adjacent to southeast corner of structure. Structure is elevated above watercourse though additional scour could compromise foundation support.

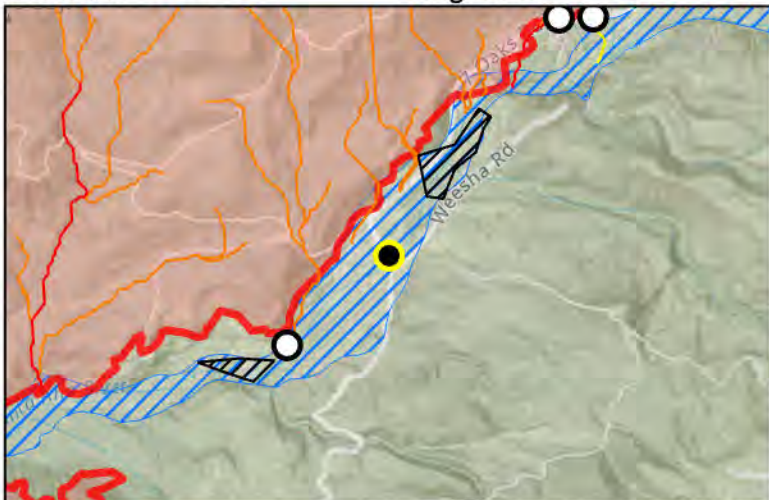
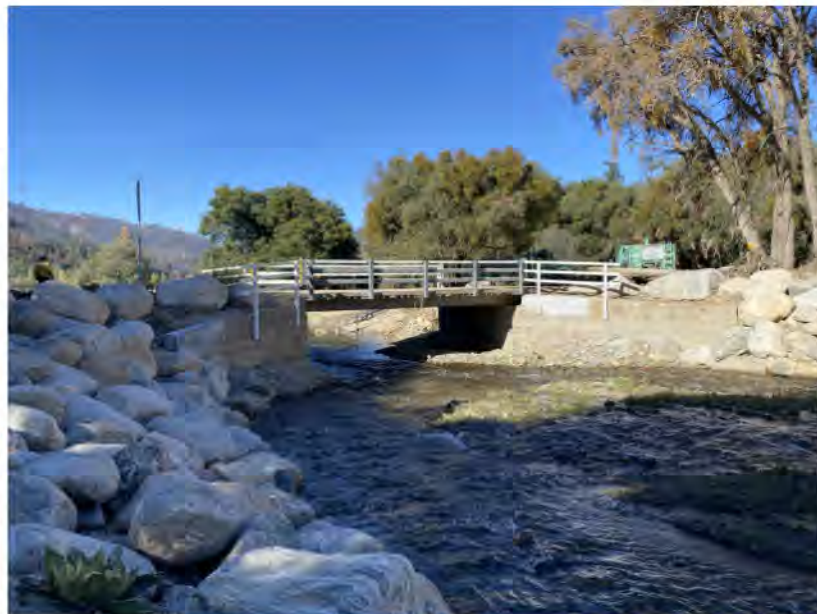
**Field Observation or** Bridge crossing over Santa Ana River drainage. Potential hazard is flood flows mobilizing debris and boulders,

**Potential Hazard:** plugging bridge culvert and overtopping. Potential for stranding residences along east bank.

**Potential Hazard to Property: moderate**

**Description:** Bridge spans 27' with 6-7' from thalweg to bottom of bridge deck. Concrete deck supported on steel I beams. Bridge is downstream of Mile Creek tributary to Santa Ana that contains steep hill slopes burned at mod and low severity. Area impacted by debris flow from TS Hilary on 8/20/23.

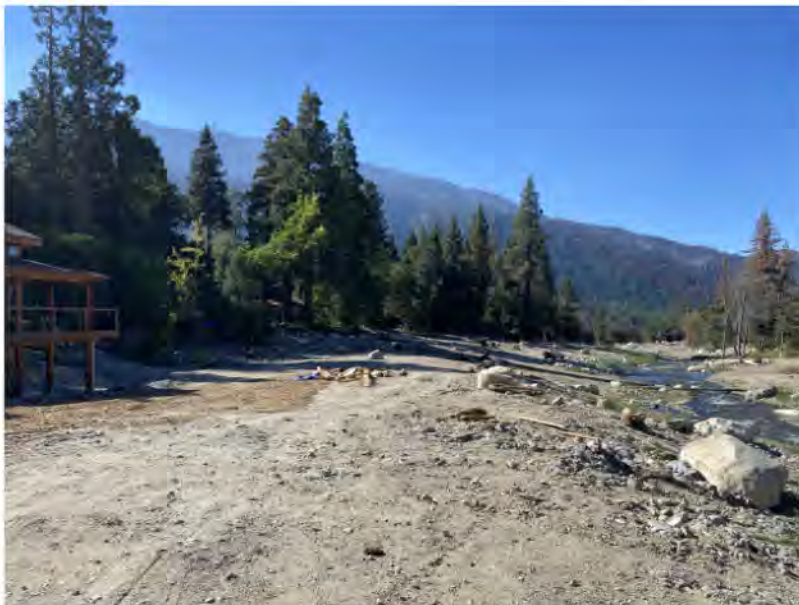
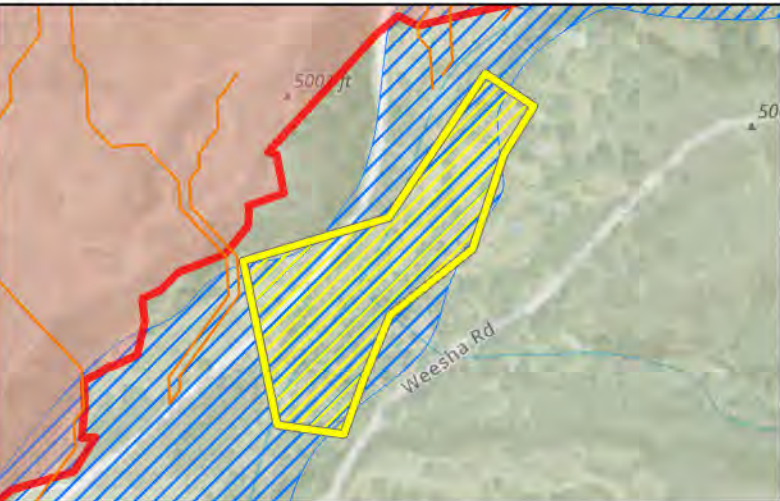
**Field Observation or** Multiple residences located adjacent to Santa Ana River watercourse. Potential hazard is debris flood  
**Potential Hazard:** overtopping channel banks and inundating homes.

**Potential Hazard to Property: moderate**

**Description:** Upstream watershed is largely outside of the burn perimeter; however, the Mile Creek tributary just upstream contains steep slopes with moderate and low burn severity. Flooding from this drainage could mobilize burned debris in Mile Canyon and downed woody debris and boulders scattered along the Santa Ana River drainage from the TS Hilary event

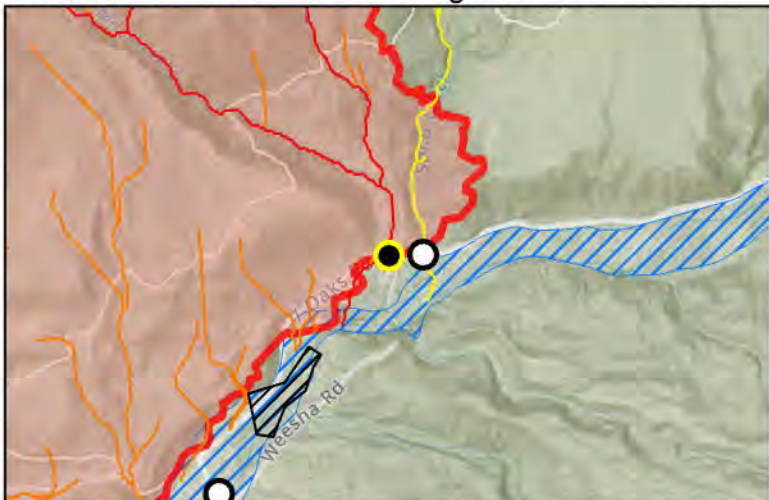
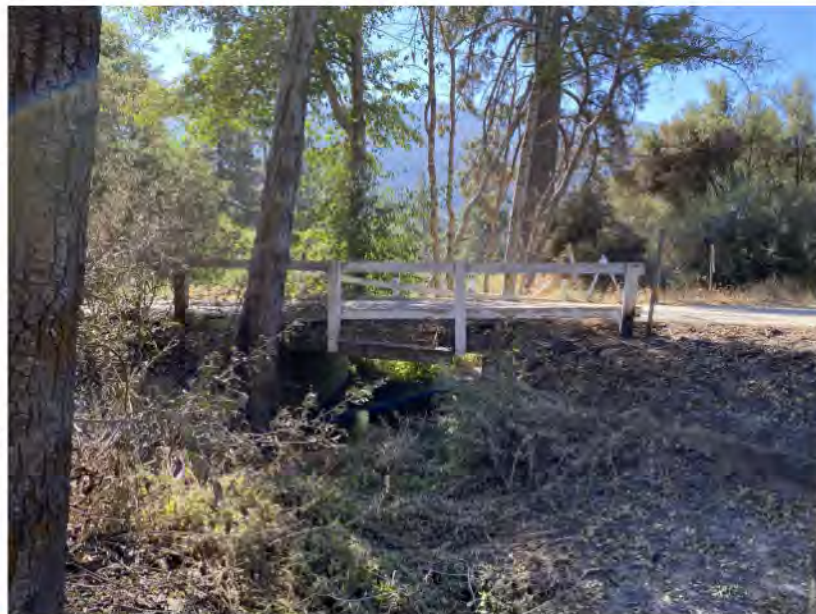
**Field Observation or** Seven Oaks Road culverted crossing over Mile Creek. Potential hazard is flood flow mobilizing woody debris, **Potential Hazard:** leading to plugging of culvert and overtopping of road. road inundation may impact ingress/egress to residences.

**Potential Hazard to Property: moderate**

**Description:** 4' x 10' box culvert with approx. 1.5 ft of freeboard. overland flow along road surface in both directions. Crossing is at road high point. Boulders and mature trees present just upstream of crossing. Mile Creek drainage burned mostly at moderate severity.

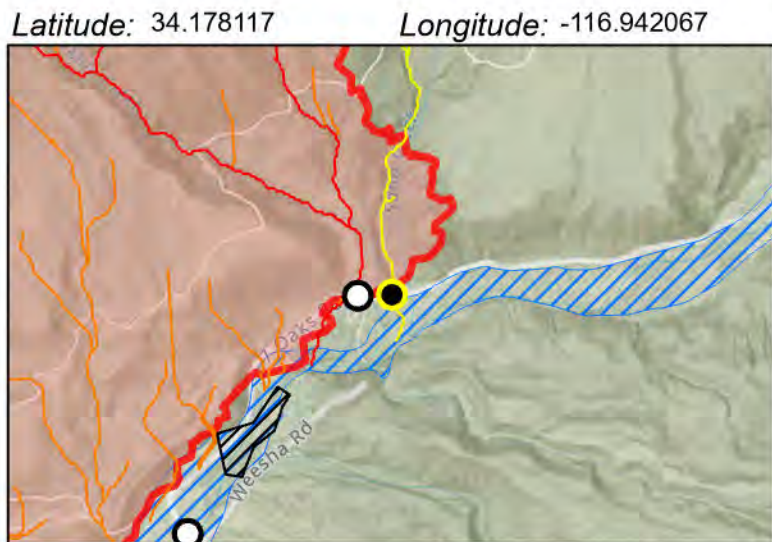
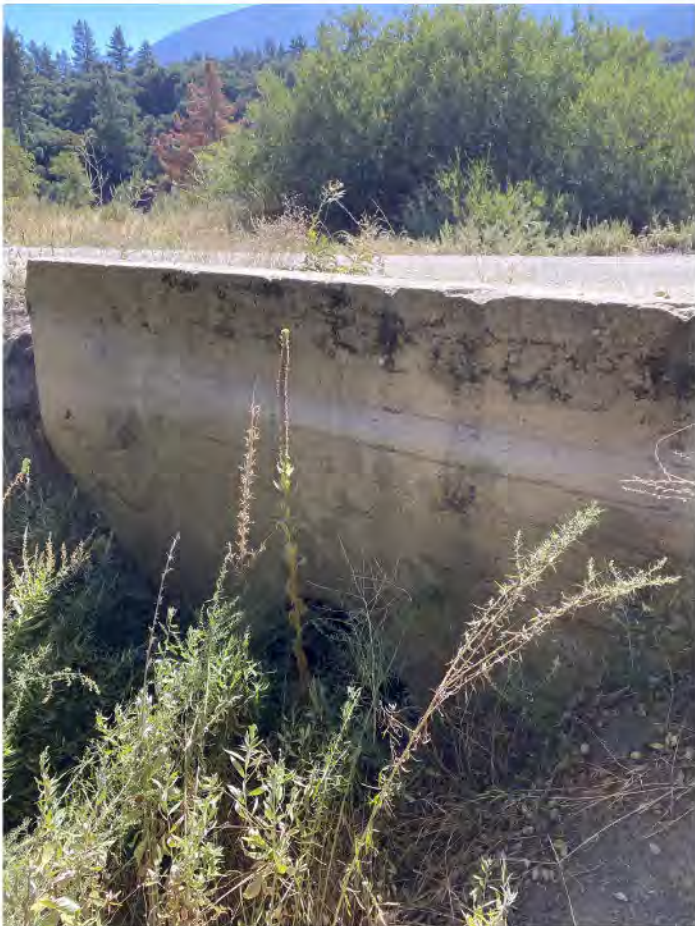
**Field Observation or** Seven Oaks Road culverted crossing over Sand Creek. Potential hazard is flood flow mobilizing woody debris, **Potential Hazard:** leading to plugging of culvert and overtopping of road. Road inundation may impact ingress/egress to residences.

**Potential Hazard to Property: low**

**Description:** 30-inch diameter RCP with 48-inch head wall. Small drainage burned at low severity.
